Yongbyon: Centrifuge Enrichment Plant Expands while 5 MWe Reactor is Possibly Shut Down

David Albright and Serena Kelleher-Vergantini

October 3, 2014

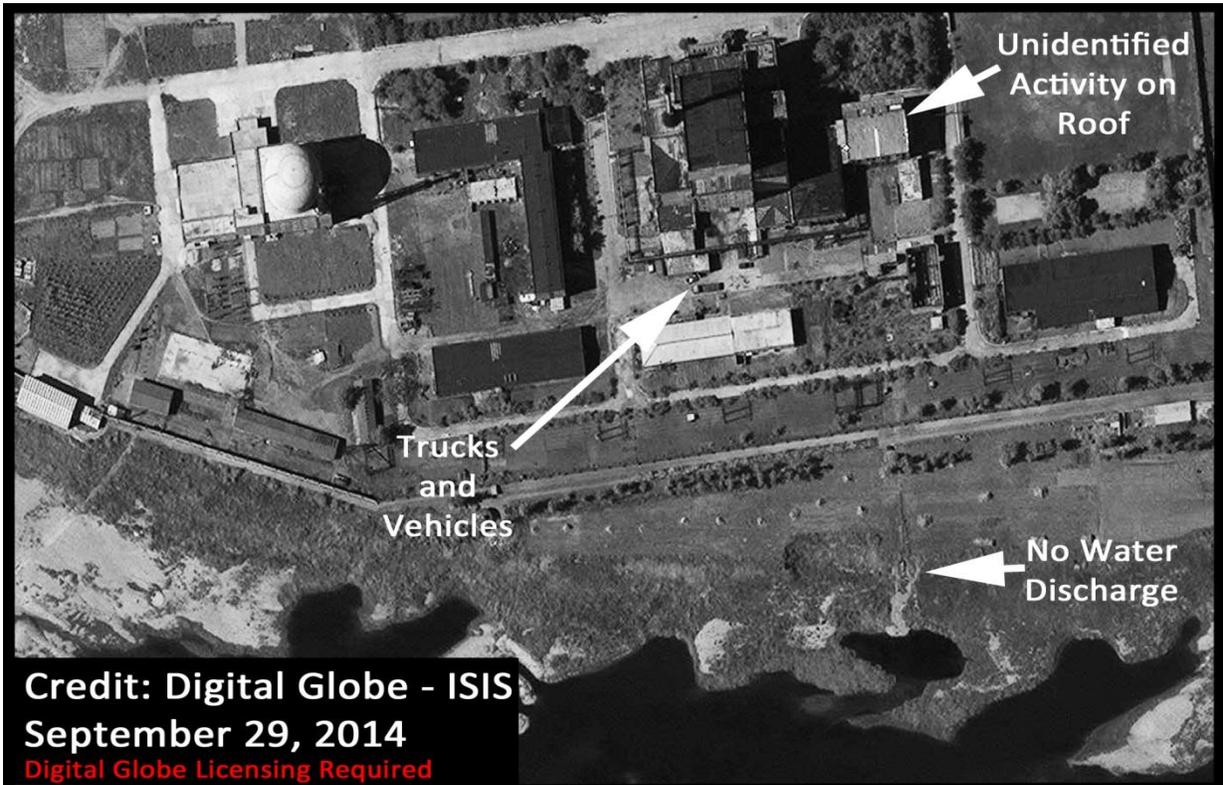
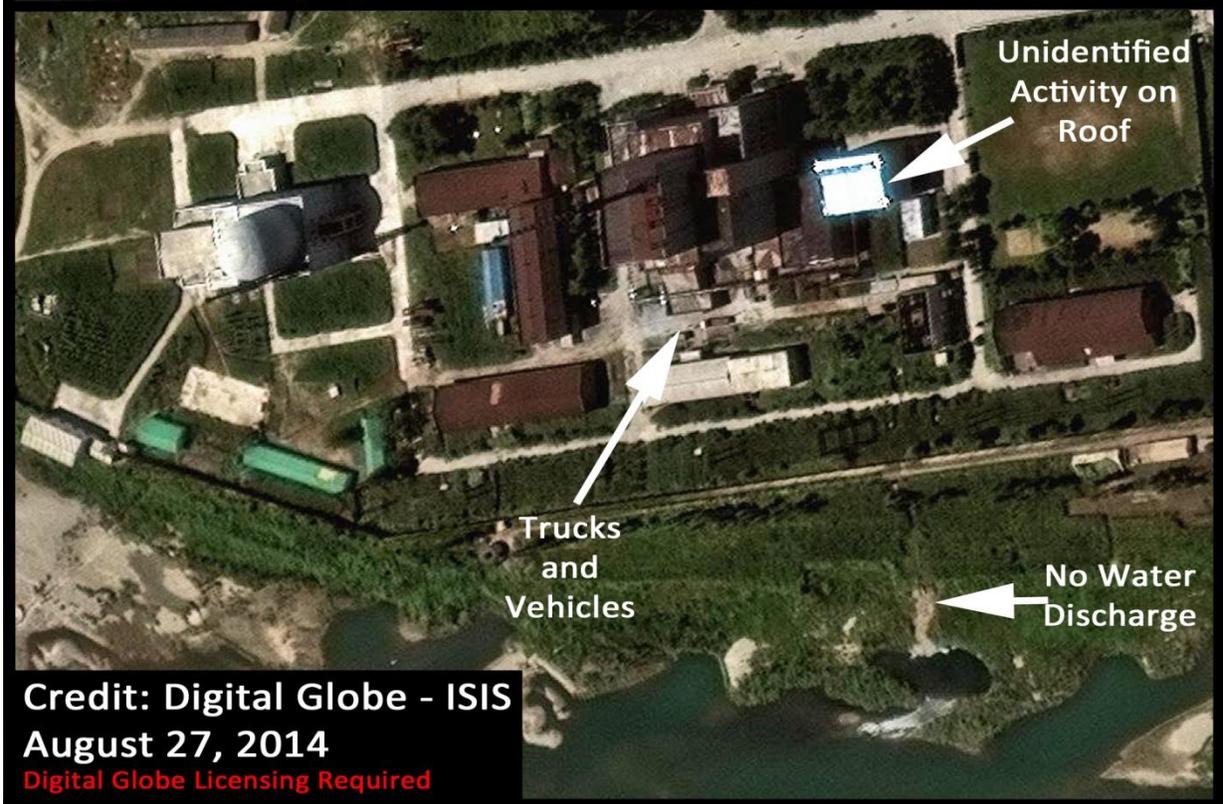
However, in imagery dated August 27 and September 29, 2014 both these signatures are missing (see figure 1). There is no steam venting from the turbine building and no water is being discharged from the secondary cooling system's discharge pipeline. For this reason, ISIS assesses that it is possible that the reactor is partially or completely shut down.

Figure 1. Digital Globe imagery showing North Korea’s Yongbyon 5 megawatt-electric (MWe) and experimental light water reactors on August 27 and September 29, 2014.

Alternatively, it is also possible that North Korea has shut down the reactor for maintenance or renovation purposes. As figure 1 shows, unidentified activity is taking place on the roof of the reactor's turbine building. In addition, one long open bed truck and a few other smaller ones are present near the reactor.

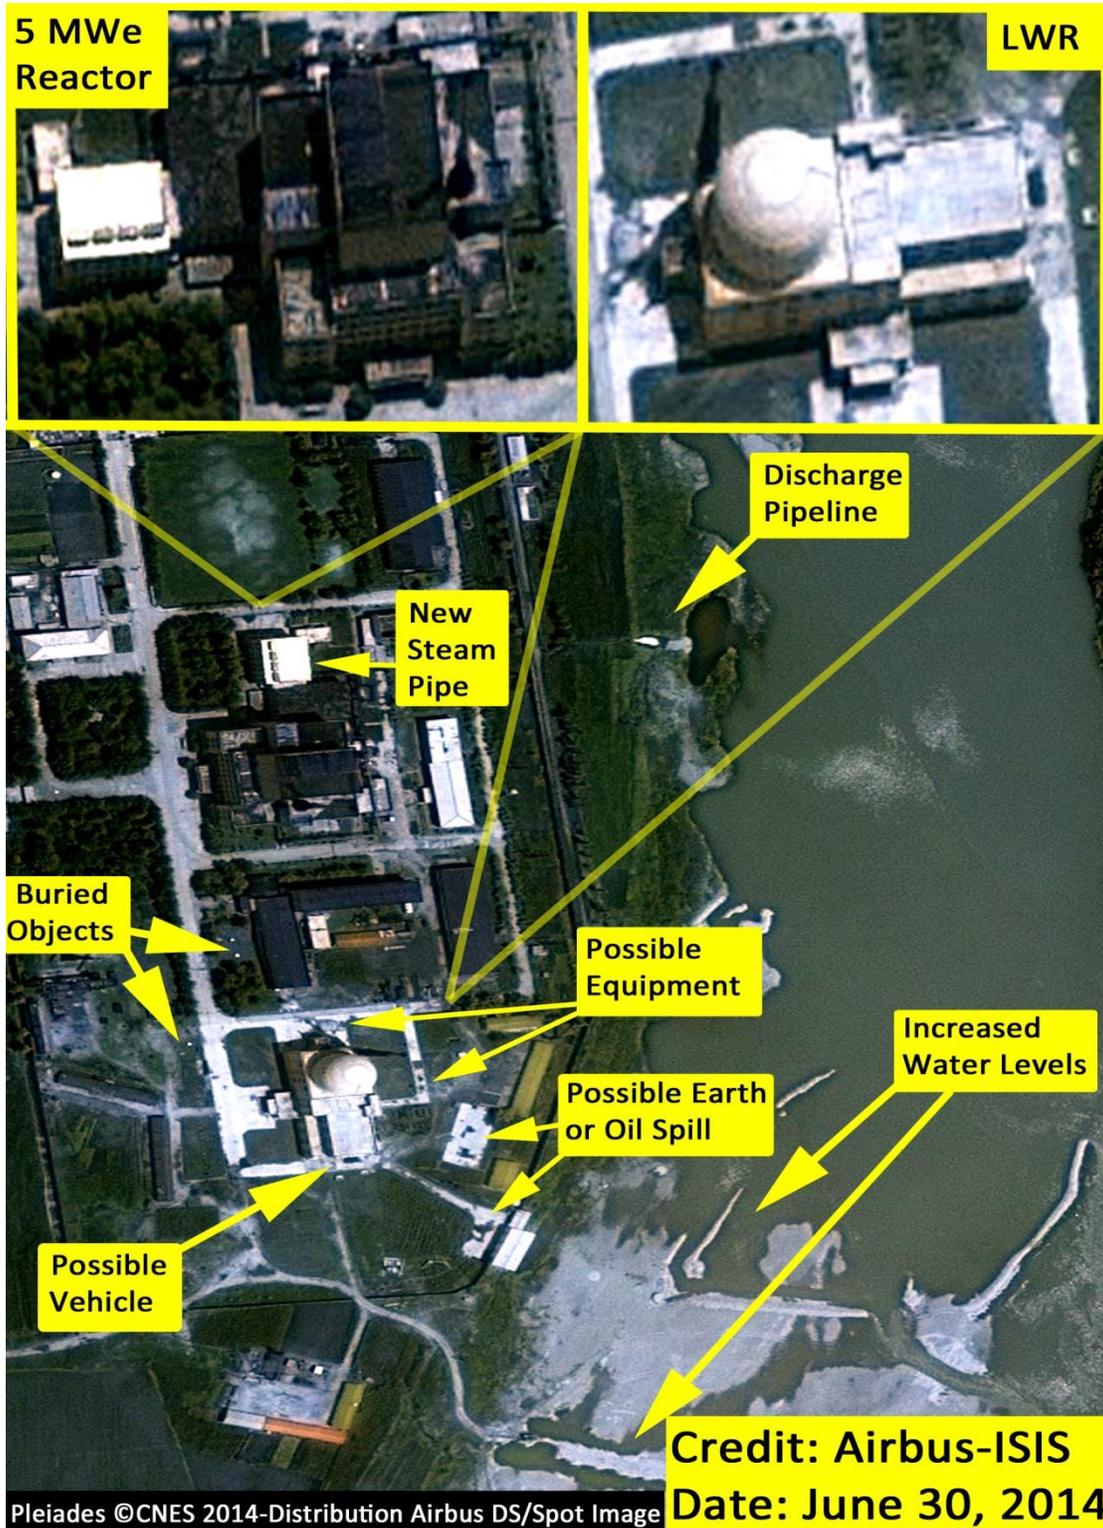
Figure 2. Airbus imagery showing North Korea's Yongbyon 5 megawatt-electric (MWe) and experimental light water reactors on June 30, 2014.

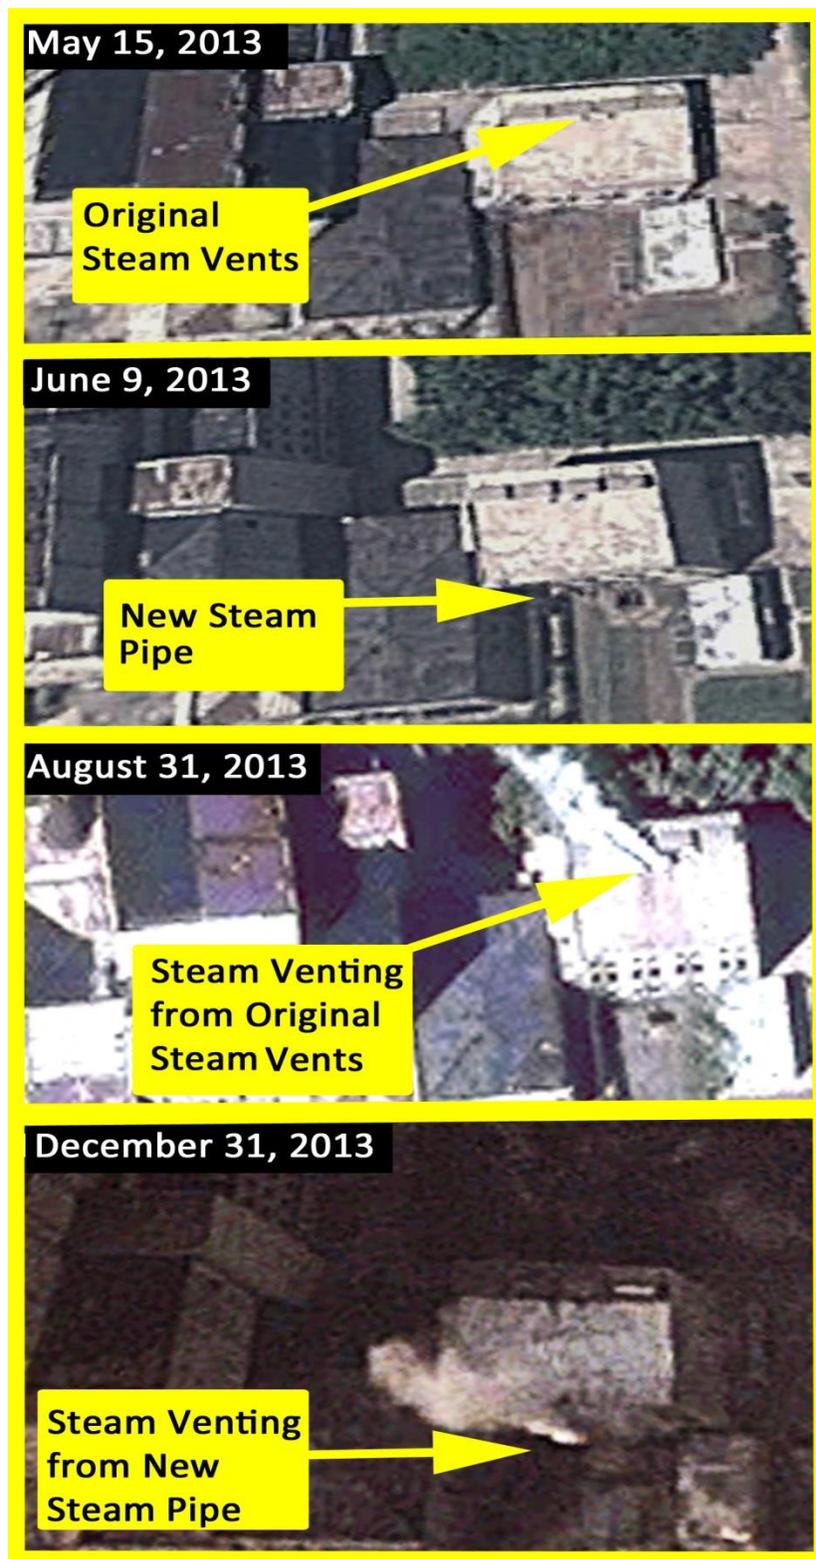
In [August 2014](#), ISIS assessed that North Korea had apparently made a decision to renovate the aged 5 MWe reactor to make plutonium for nuclear weapons. As figure 3 shows, North Korea has apparently remodeled the reactor's secondary cooling system, including replacing a steam line out of the reactor (between May and June 2013 North Korea installed what appears to be new piping).

Figure 3. Digital Globe and Google Earth imagery showing the 5 MWe reactor and steam venting between May 15, 2013 and December 31, 2013.

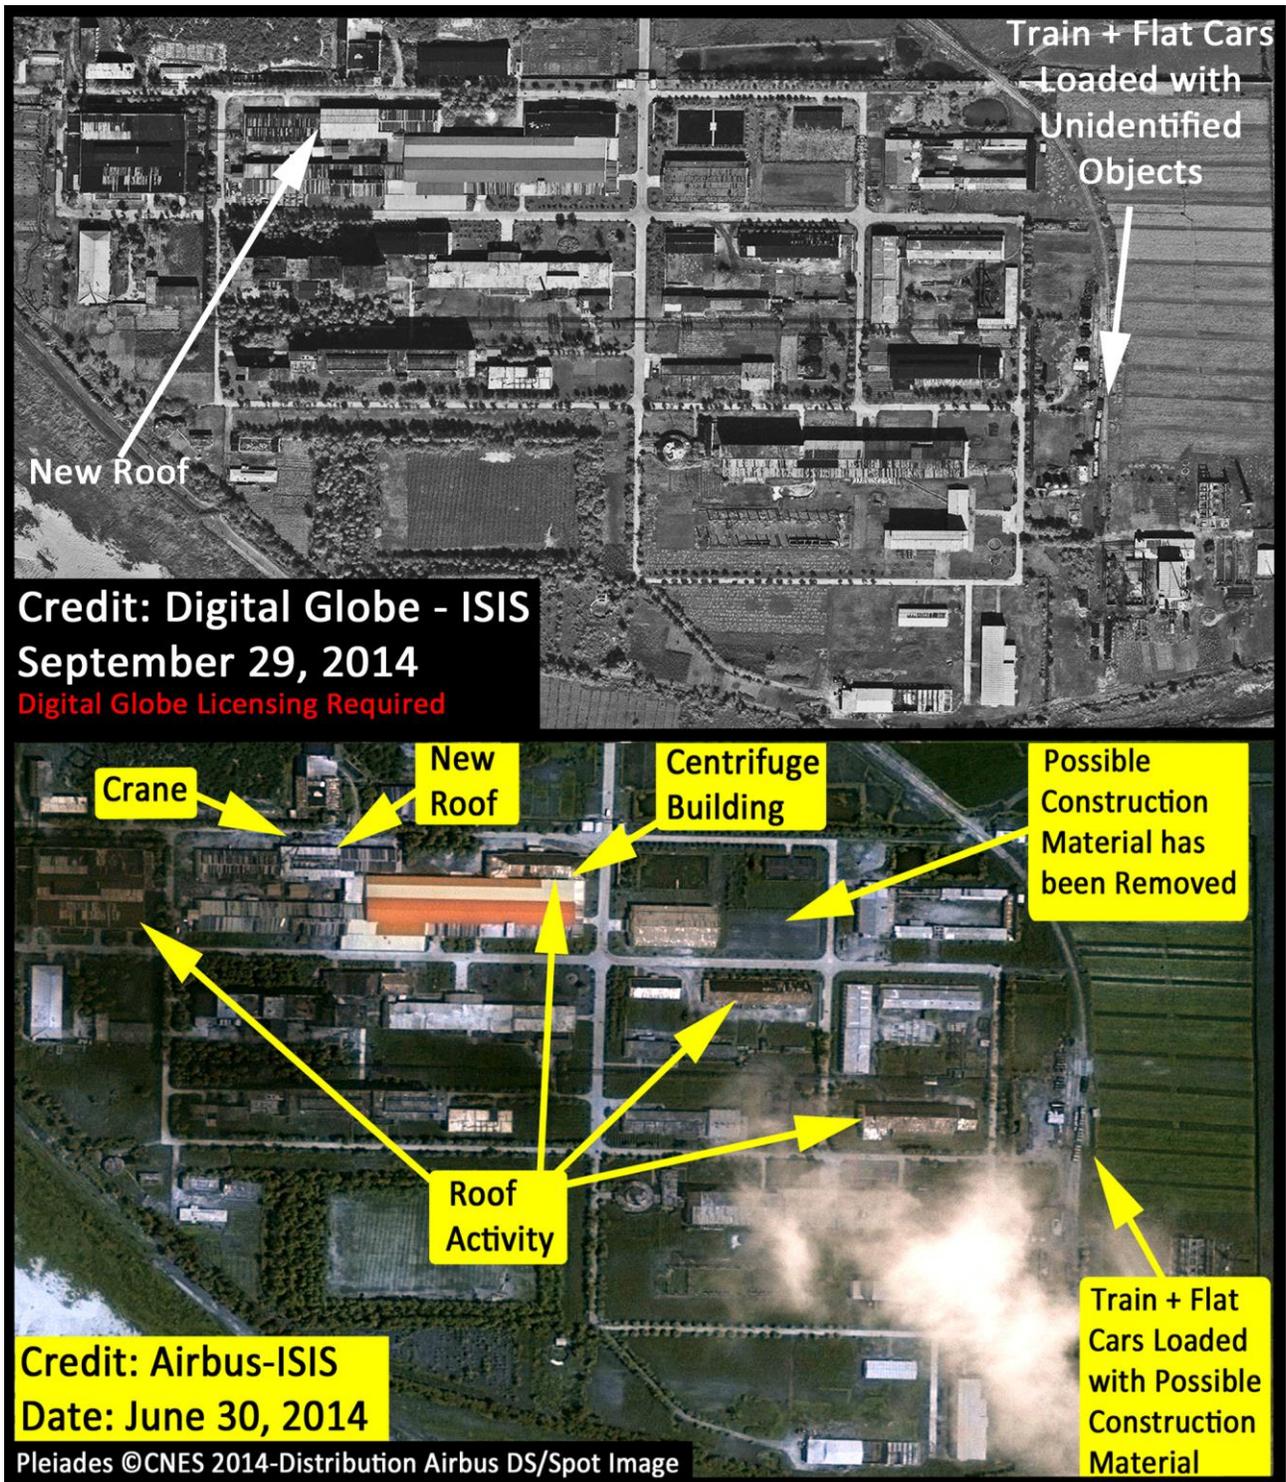
The most recent imagery dated August 27 and September 29, 2014, shows that North Korea has continued to renovate additional sections of the roof of a building adjacent to the main centrifuges building (see figure 4). Also, a train with flat cars carrying unidentified objects is visible on the tracks to the east of the site.

Figure 4. Digital Globe and Airbus imagery showing the status of North Korea’s Yongbyon Fuel Fabrication Complex on June 30 and September 29, 2014.

In [August 2013](#), ISIS showed that North Korea nearly doubled the size of the gas centrifuge building and that in [December 2013](#) it had renovated an additional section of the old roof of the centrifuge building. Imagery from April and June 2014 showed no signs of external construction activity at the centrifuge building are present, but there were several other signs of activity nearby (see figure 4 or [here](#)).
