Update on North Korean Light Water Reactor Construction Project

By David Albright and Robert Avagyan

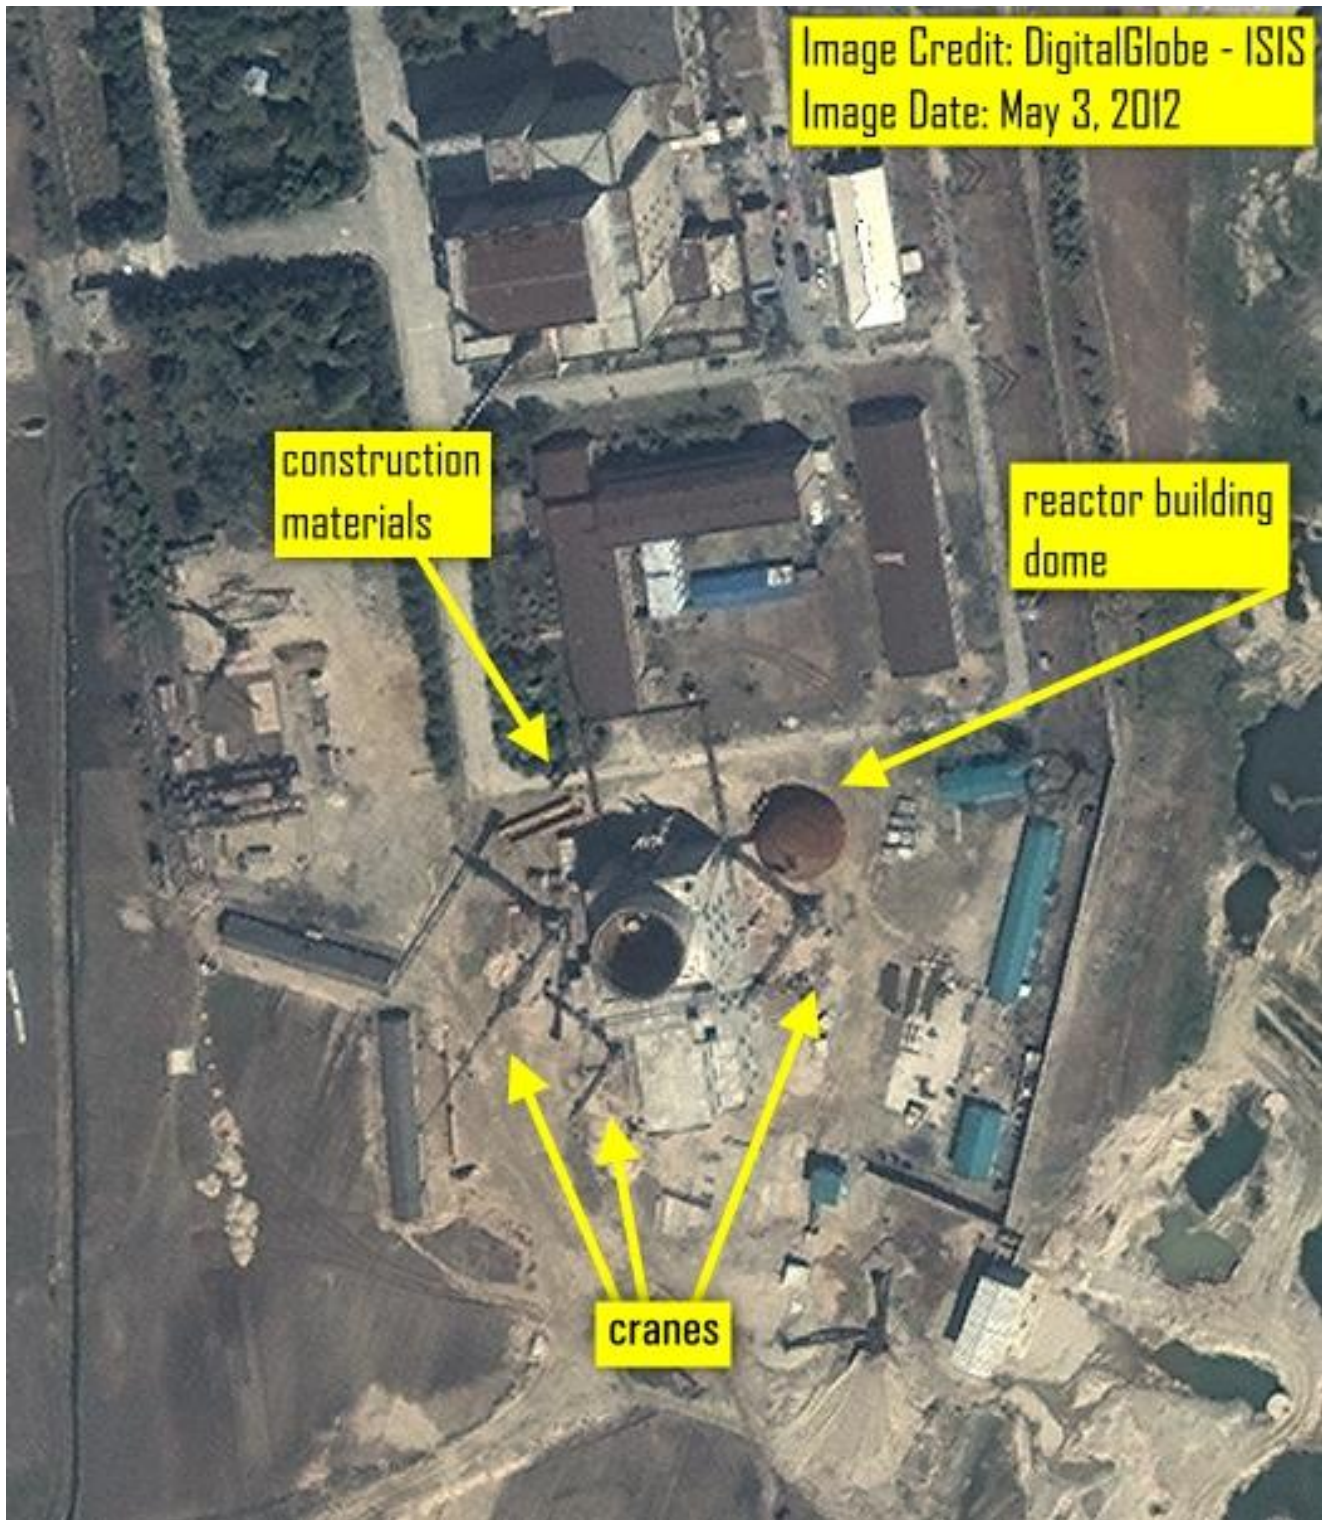
Figure 1. Satellite imagery from May 3, 2012 showing construction materials and support equipment waiting to be placed on the reactor building.

Cranes can be seen around the building in the May 3, 2012 imagery (figure 1). By June 5, 2012, a rectangular steel structure of considerable height is erected adjacent to the northern façade of the reactor building (figure 2). In June 24, 2012 GeoEye imagery, two metal beams appear to have been placed across the open roof of the reactor chamber (figure 3). These new additions could serve to lift and lower heavy components into the reactor building. Alternatively, the beams could be part of the support structures for the reactor dome, which could be placed on the building in the near future.

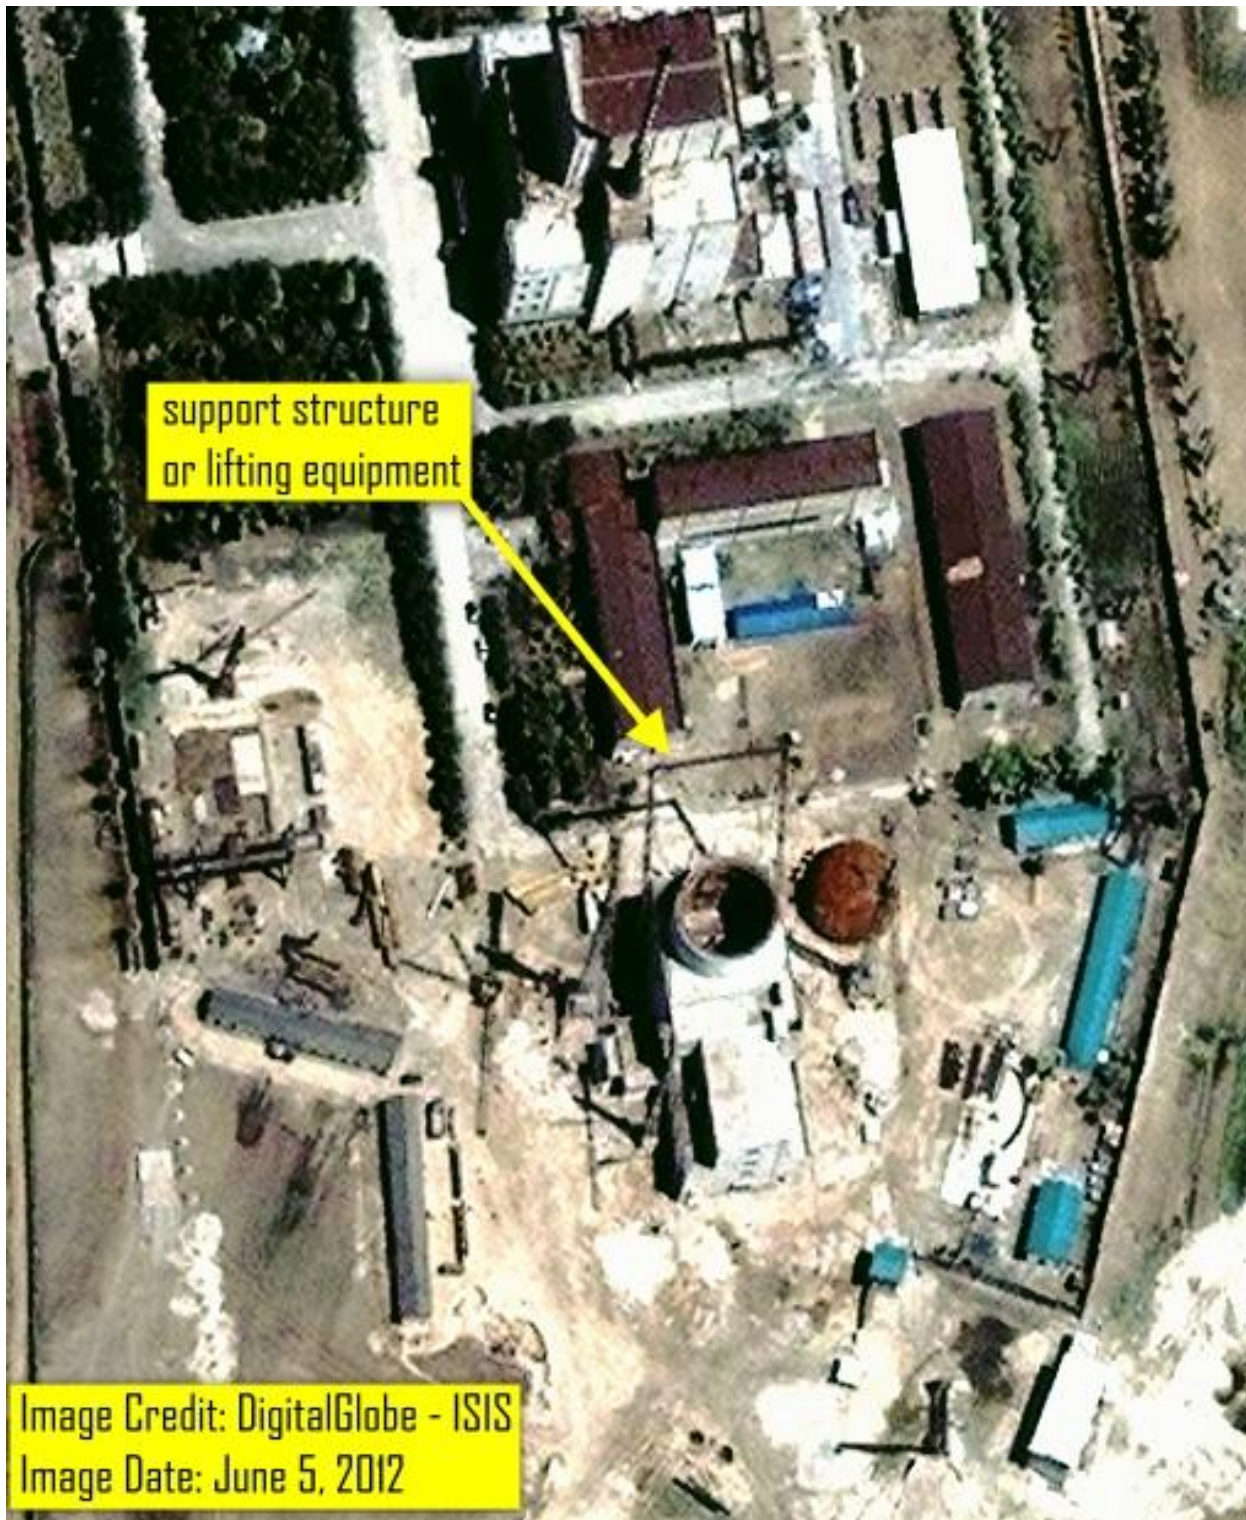
Figure 2. In the June 5, 2012 imagery from DigitalGlobe a support structure erected on the northern side of the reactor building is visible.

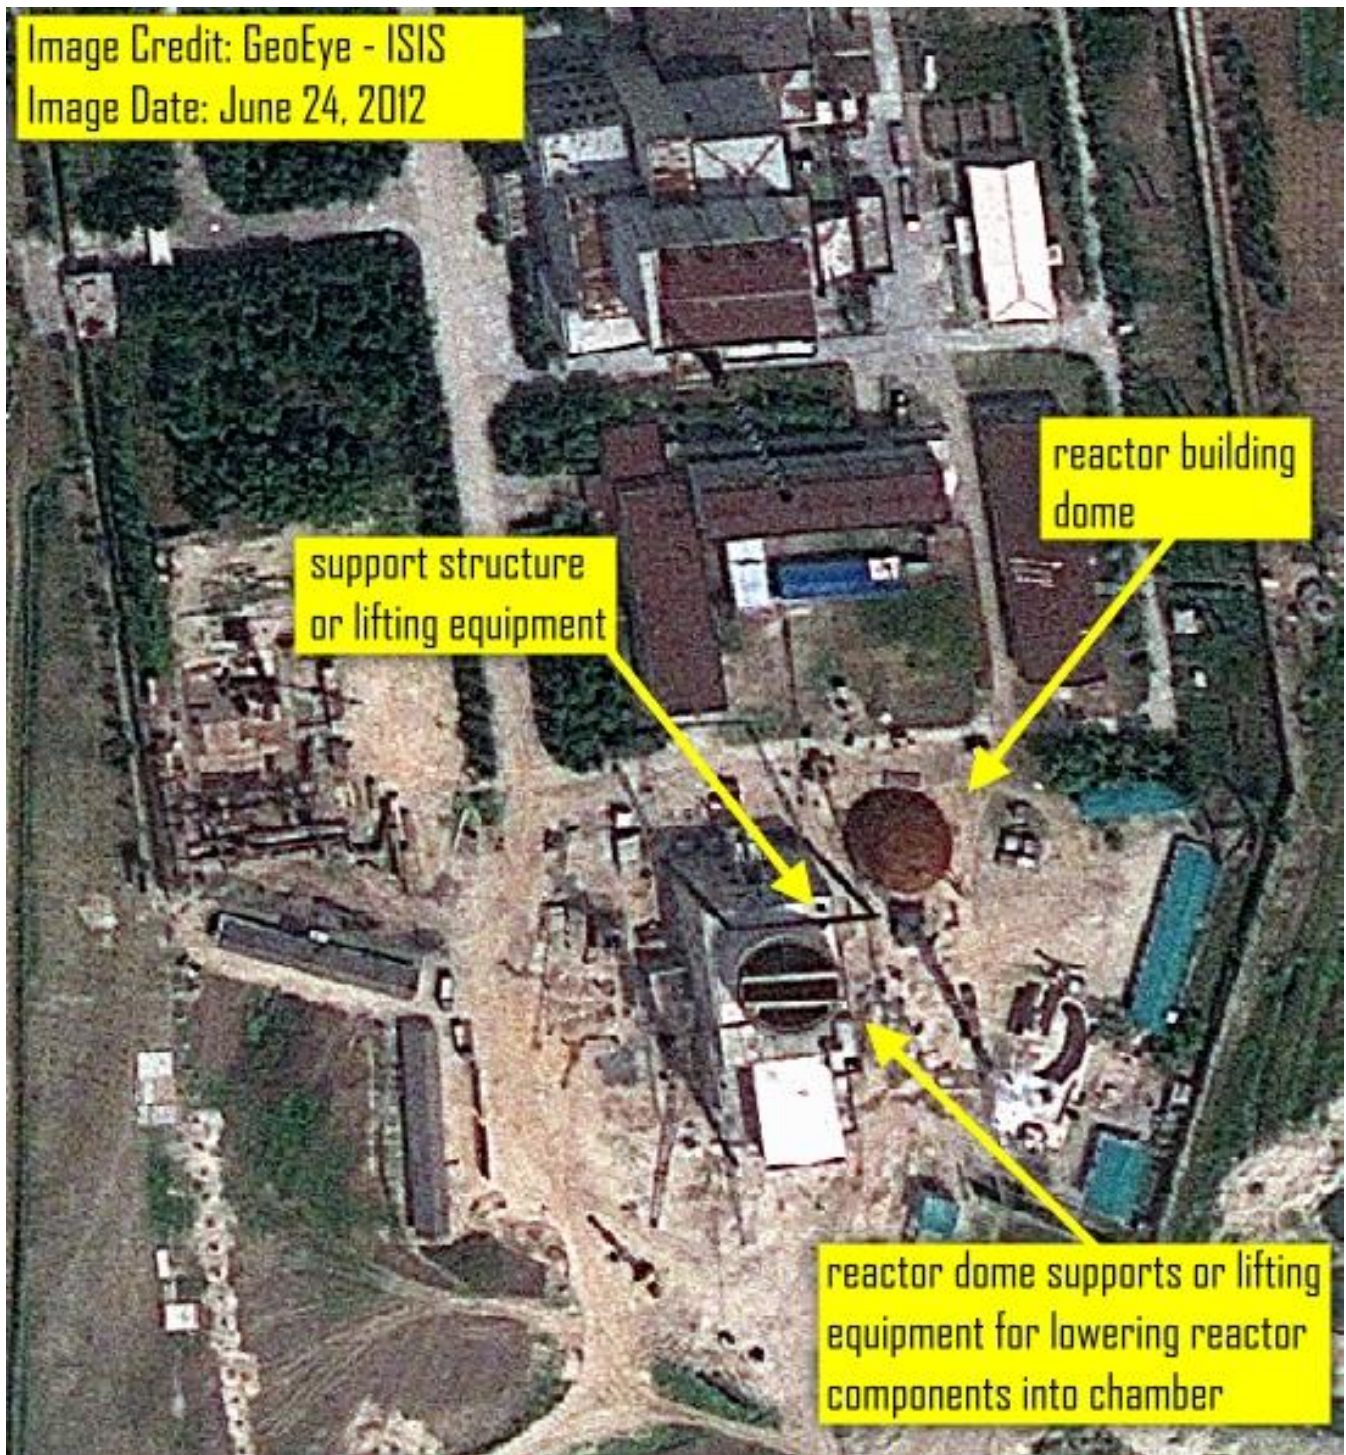
Image Credit: GeoEye - ISIS
Image Date: June 24, 2012

Figure 3. June 24, 2012 GeoEye satellite imagery provided to ISIS by TV sation NKR shows the rectangular metal structure deccribed in figure 2 still clearly visible as are two metal beams placed across the open roof of the reactor that could serve as supports for the reactor dome or be used to move equipment in the reactor building.

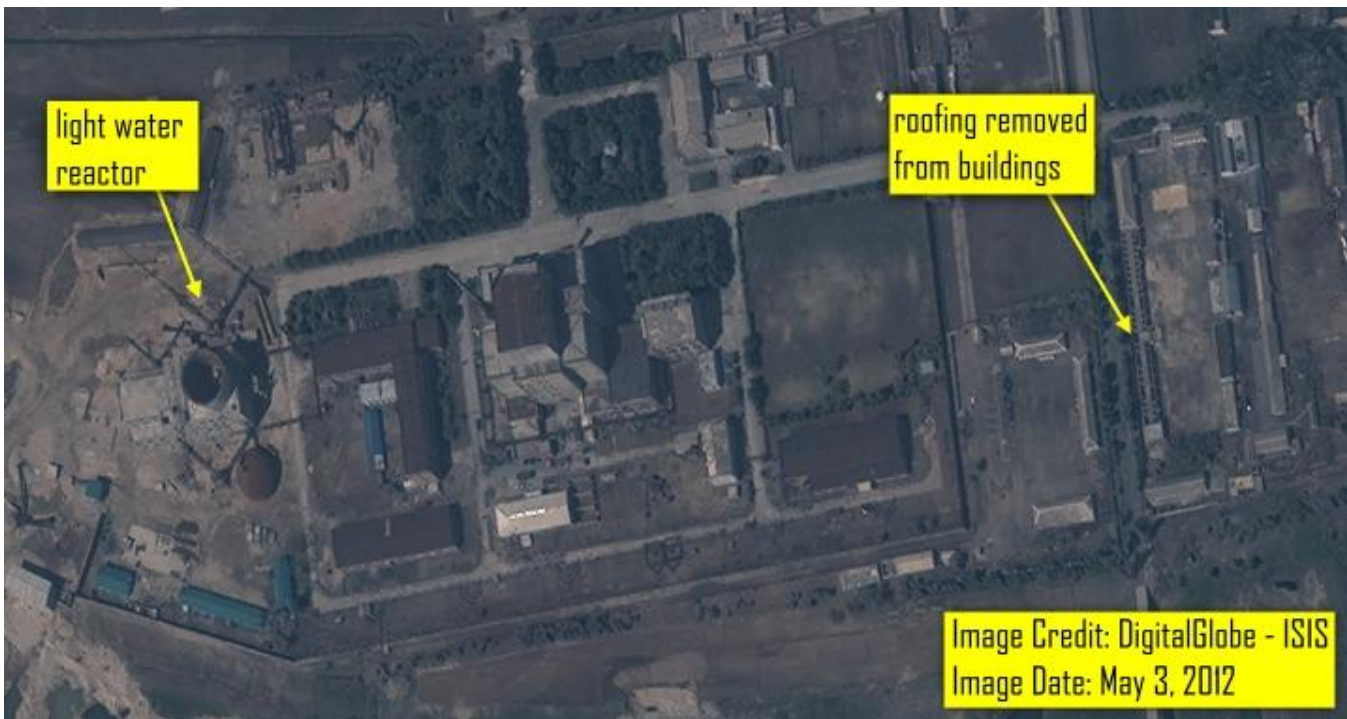
Figure 4. A wide area view of the Yongbyon LWR complex showing ongoing construction work on two buildings north of the reactor building.

In addition to the work on the LWR complex, construction activity occurred on a series of buildings to the north of the LWR. As seen in the May 3, 2012 imagery (figure 4) roofing was stripped off two adjacent buildings which were then combined into a single building with a common roof as visible in the June 5, 2012 imagery (figure 5).

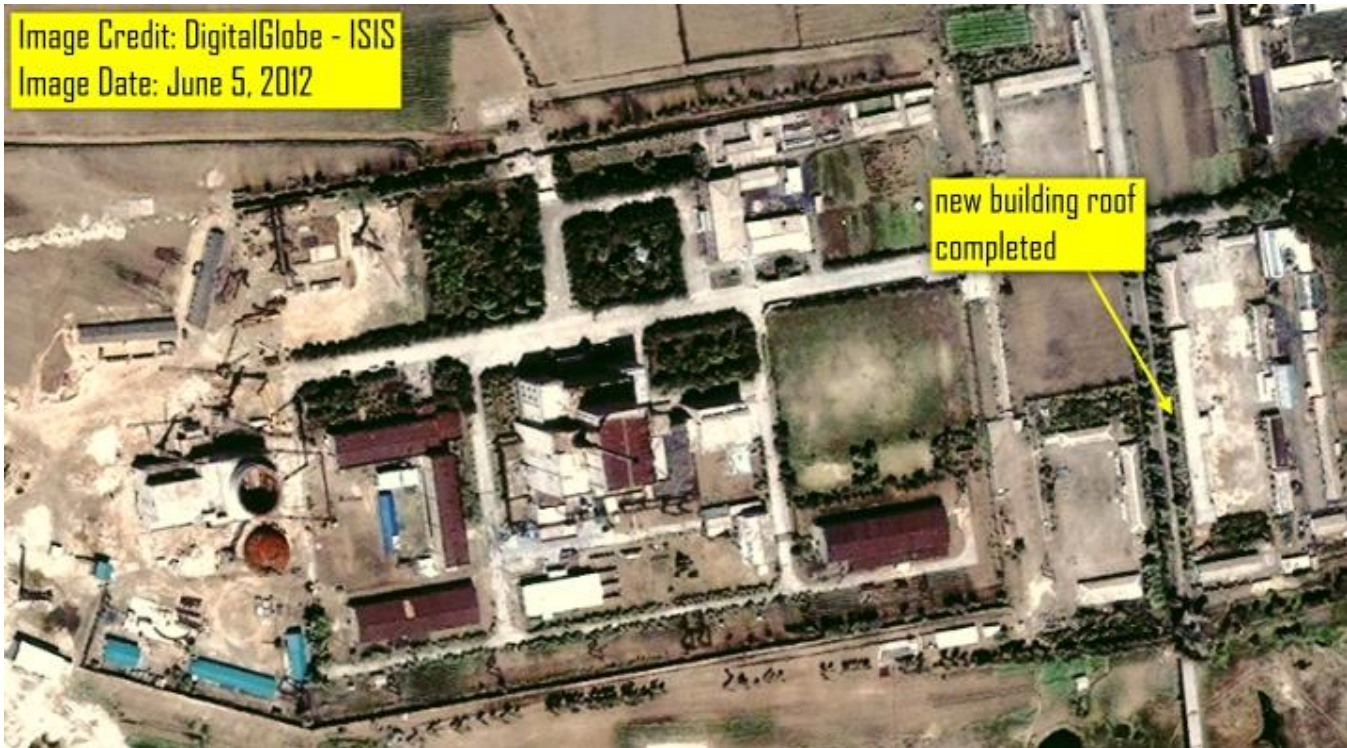
Figure 5. The June 5, 2012 imagery shows the completed external construction of the buildings in figure 4 that have now been combined under a single roof.

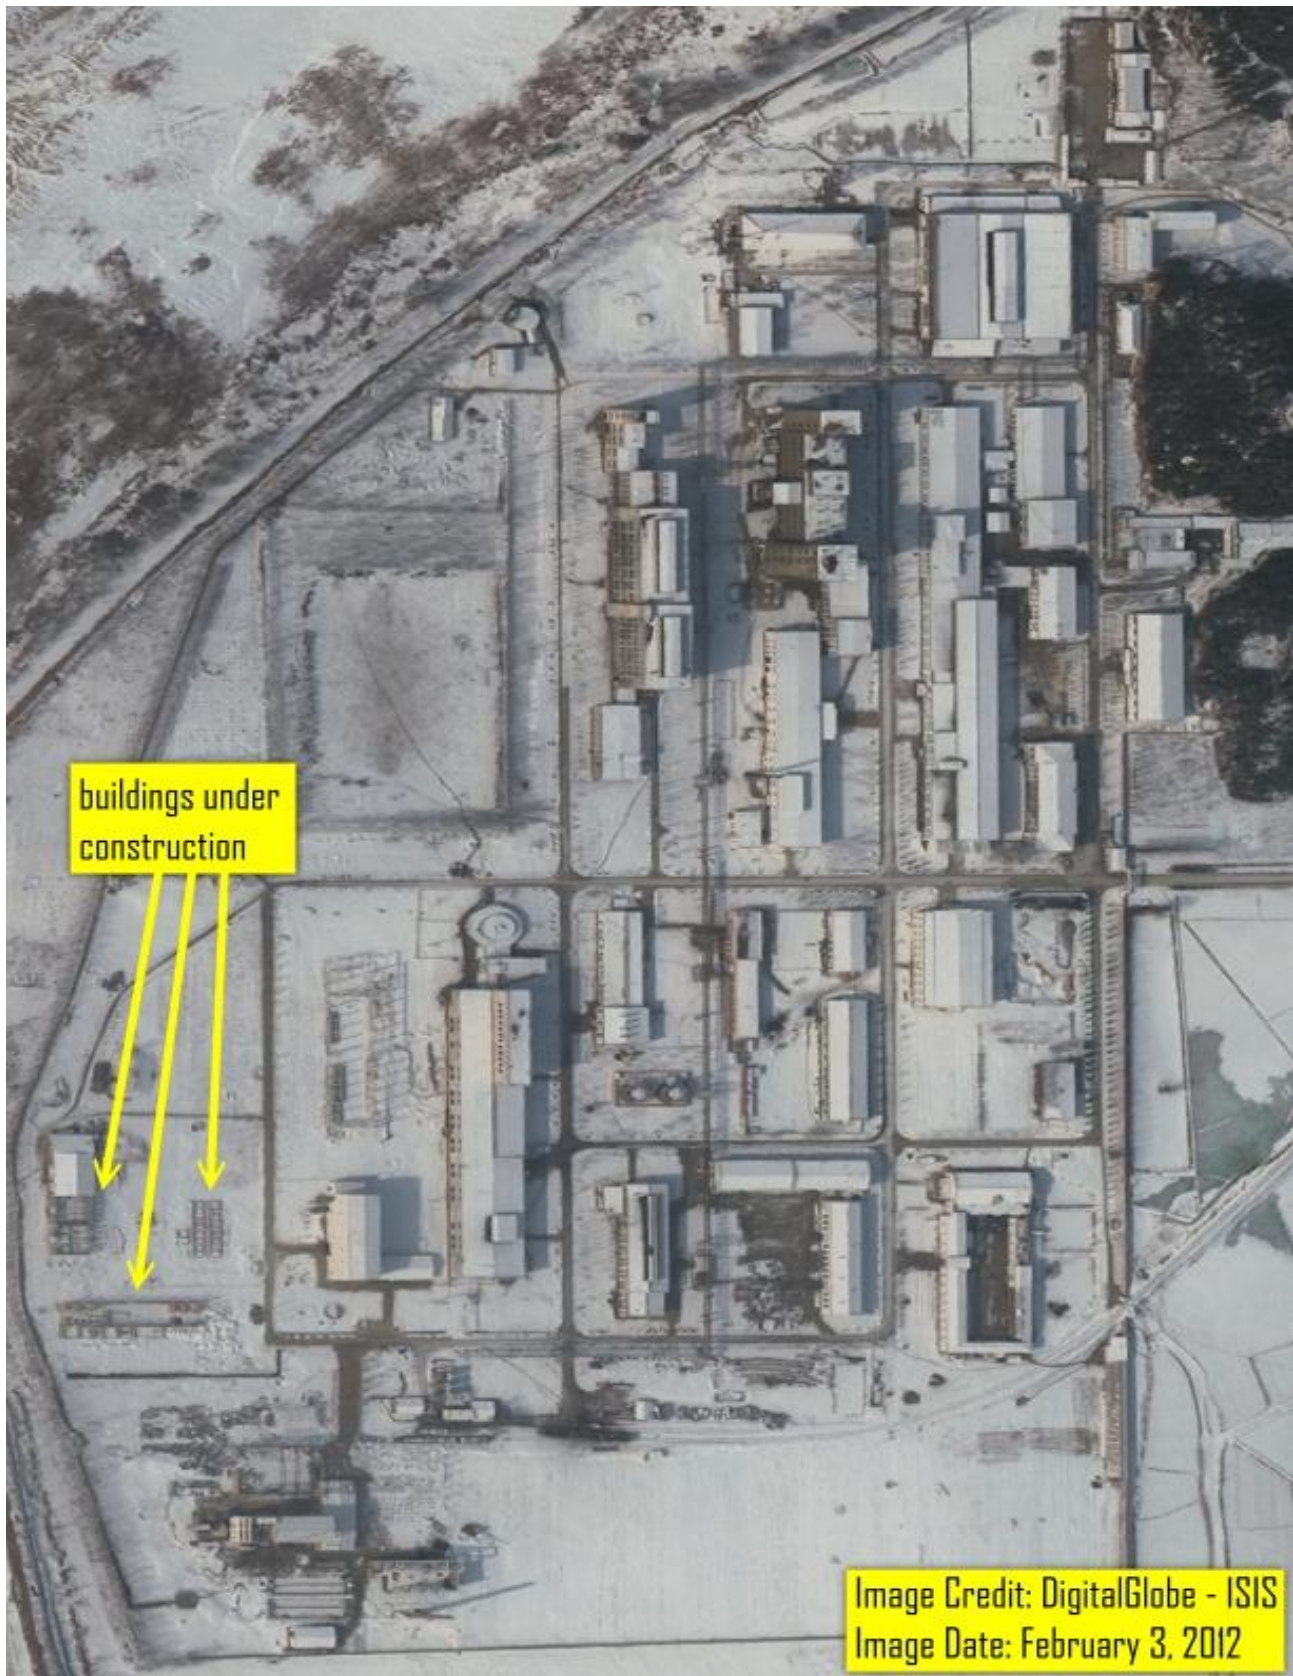
Figure 6. February 3, 2012 imagery of the fuel fabrication complex in Yongbyon showing ongoing construction on a group of 3 buildings in the southern part of the site that houses a gas centrifuge plant.

The fuel fabrication facility is also the site of additional construction activity. This site houses a gas centrifuge plant. The February 3, 2012 imagery shows three buildings under construction in the southeast corner of the facility (figure 6). In the June 5, 2012 imagery the southern most building appears completed while construction continues on the other two buildings with the addition of interior walls and sections of roofing (figure 7).

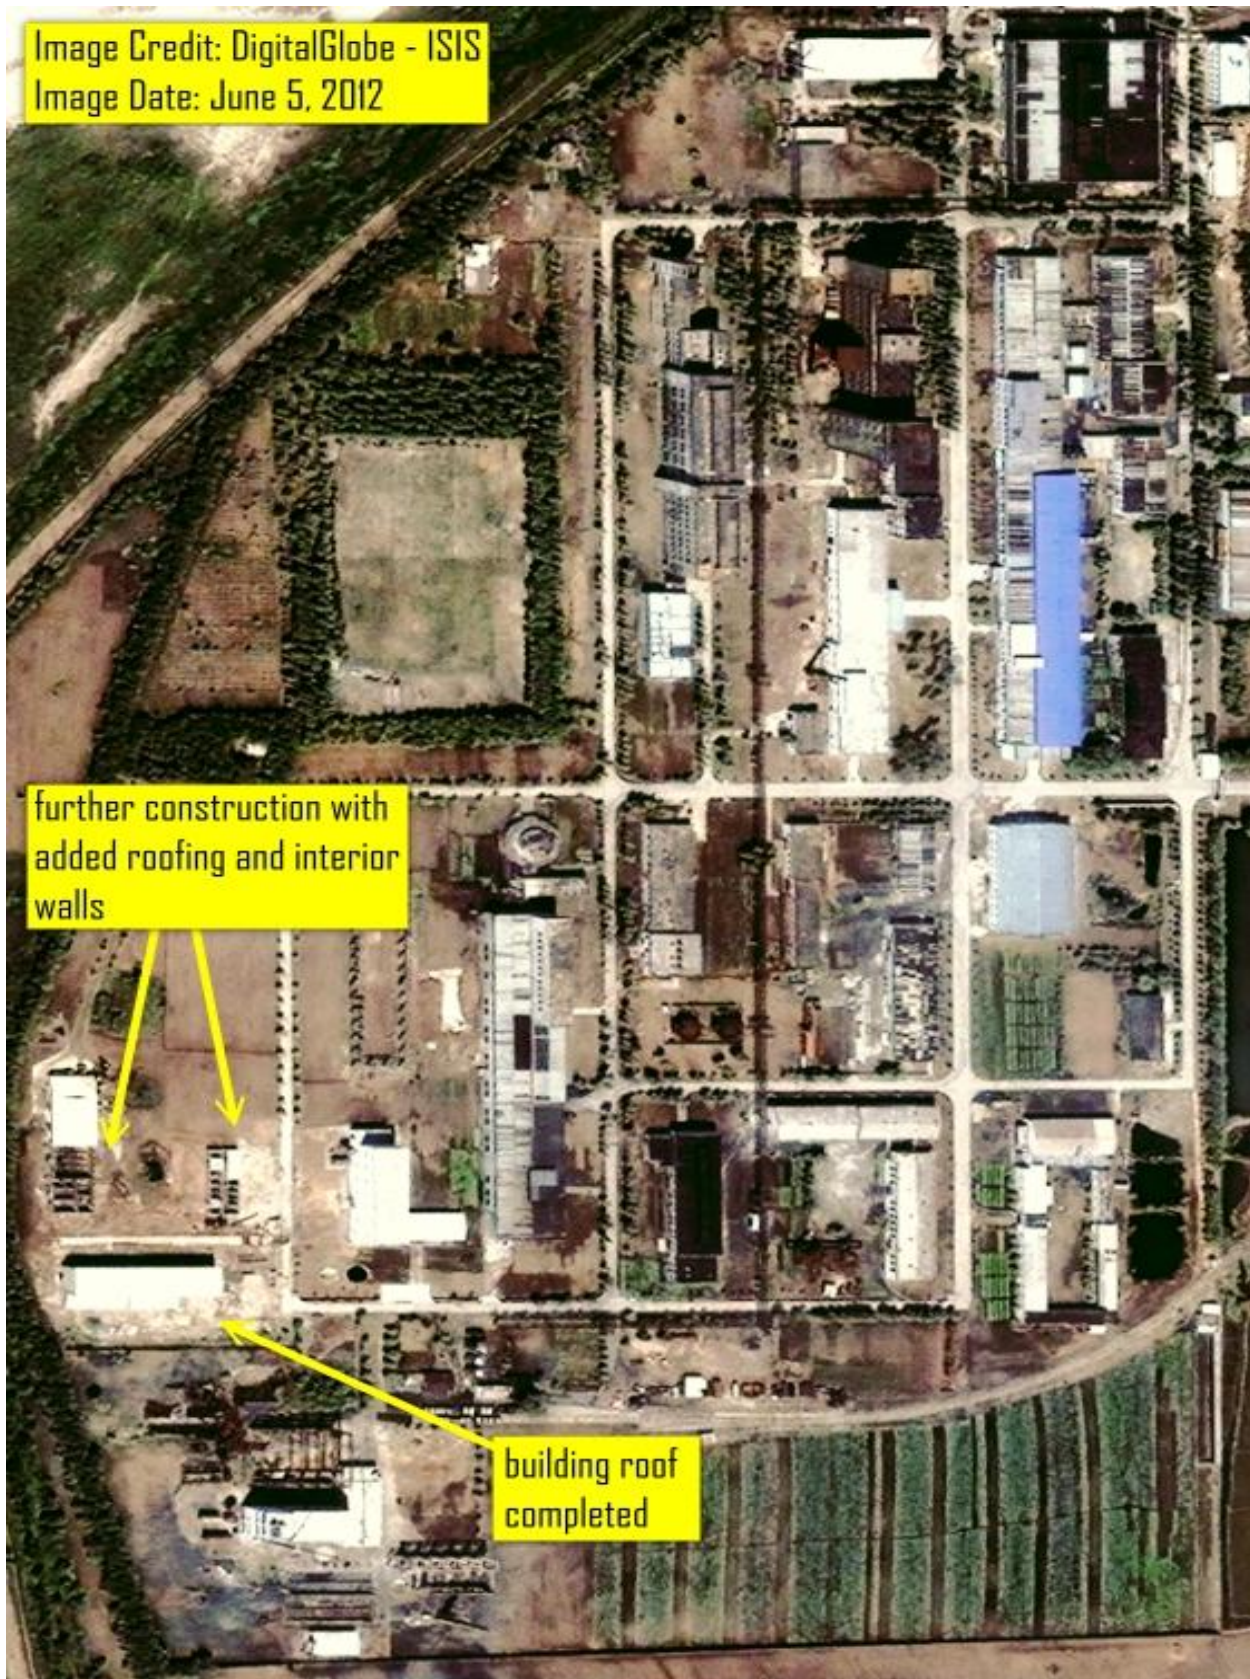
Image Credit: DigitalGlobe - ISIS
Image Date: June 5, 2012

further construction with added roofing and interior walls

building roof completed

Figure 7. June 5, 2012 image showing the completed exterior of the southernmost of the buildings under construction in the Yongbyon fuel fabrication complex described in figure 6. Construction on the other two buildings is ongoing.

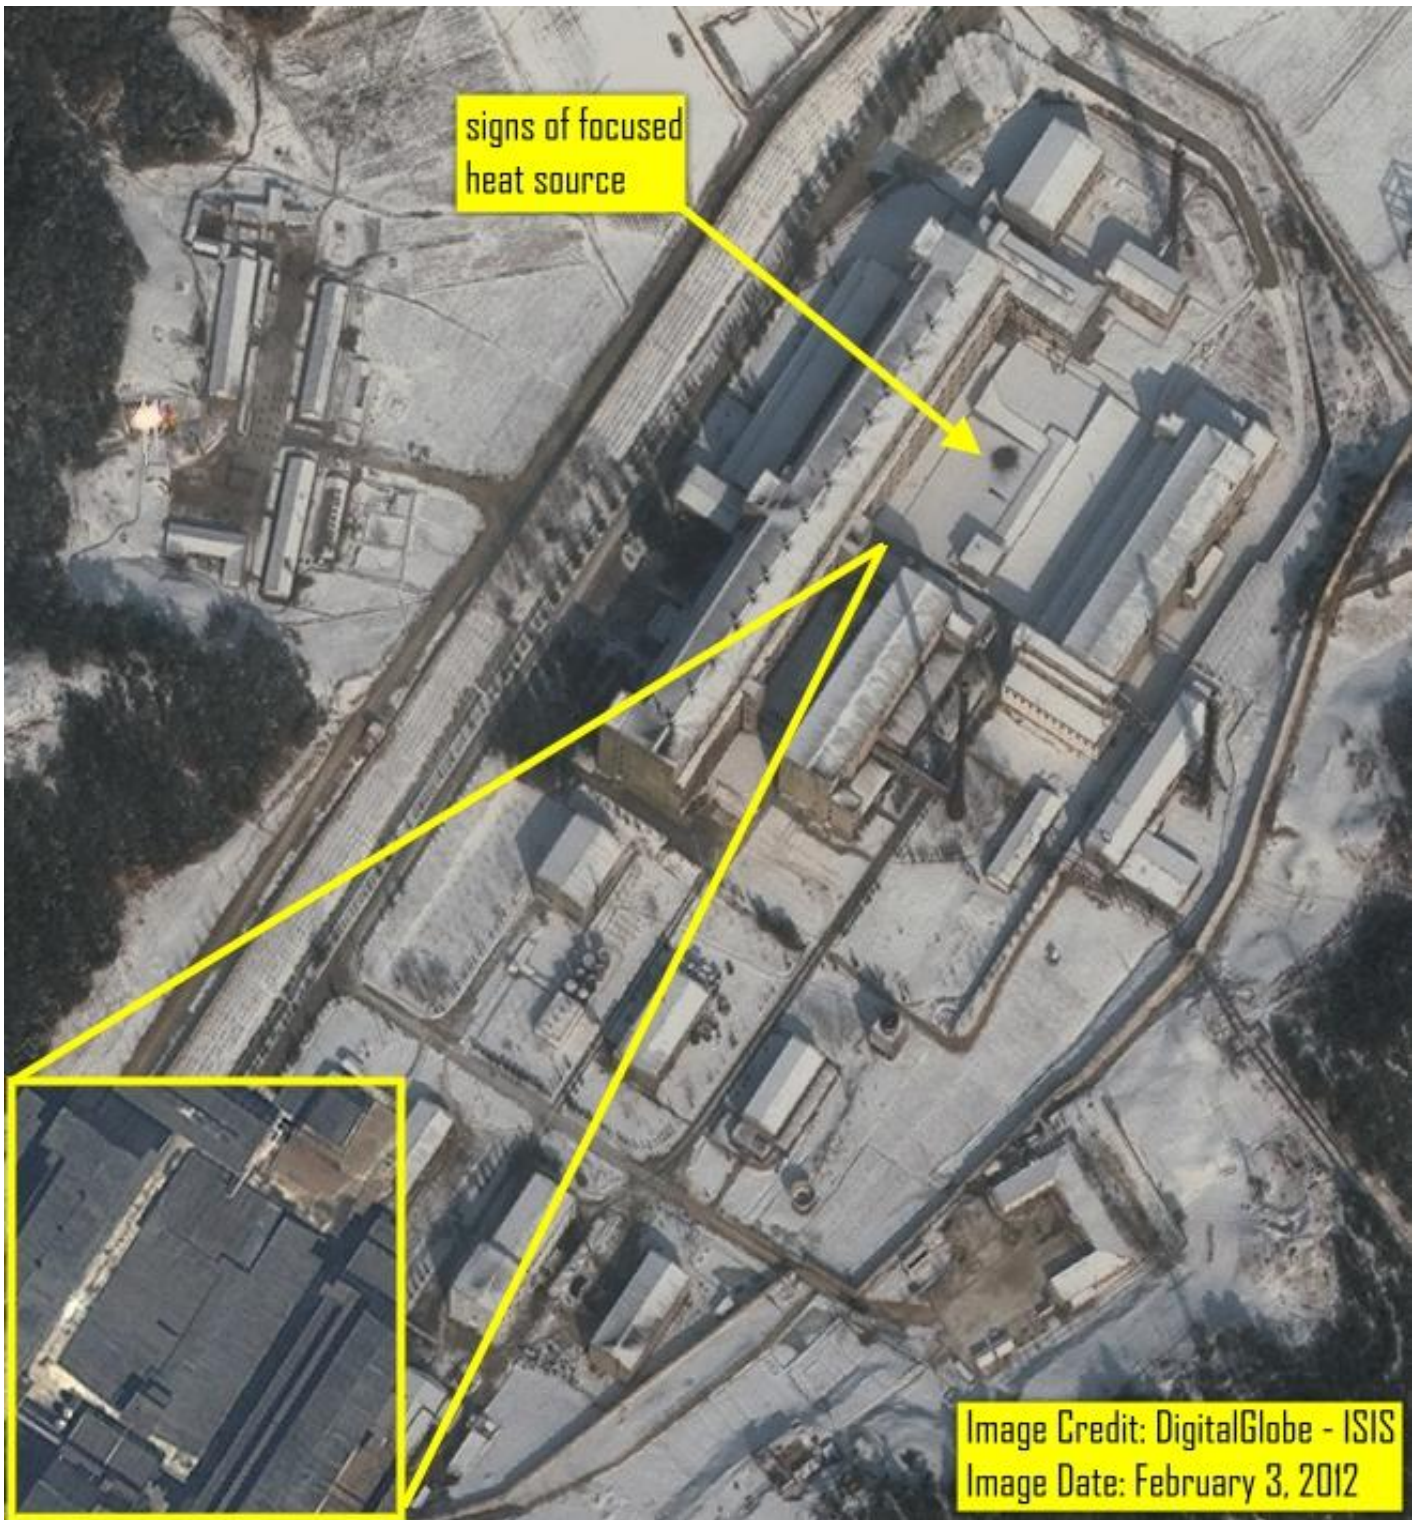
Figure 8. February 3, 2012 image of the complex that houses the plutonium separation site for the Yongbyon 5 MWe reactor. Clearly visible on the roof of a building is a section that is not covered by snow suggesting the presence of a strong heat source. A snapshot of the same area from later imagery shows no discernible features that would otherwise justify the lack of snowfall on the specific area.

The Radiochemical Laboratory, which separated plutonium from irradiated fuel from the now non-operating five megawatt-electric (MWe) Yongbyon reactor, may be used to separate plutonium produced in the LWR, possibly for use in nuclear weapons (figure 8).

The February 3, 2012 image, taken after snowfall, shows a curiously clear patch on the roof of one of the support buildings, suggesting a source of considerable heat under that part of the roof (figure 8). In later images, this section of the building appears to have no distinguishing factors. This building is adjacent to the long “canyon” where the fuel is processed and plutonium separated. This building may store hot radioactive waste or have another source of heat.
