ISIS Response to South Korean Foreign Minister's Comments on Yongbyon

David Albright and Serena Kelleher-Vergantini

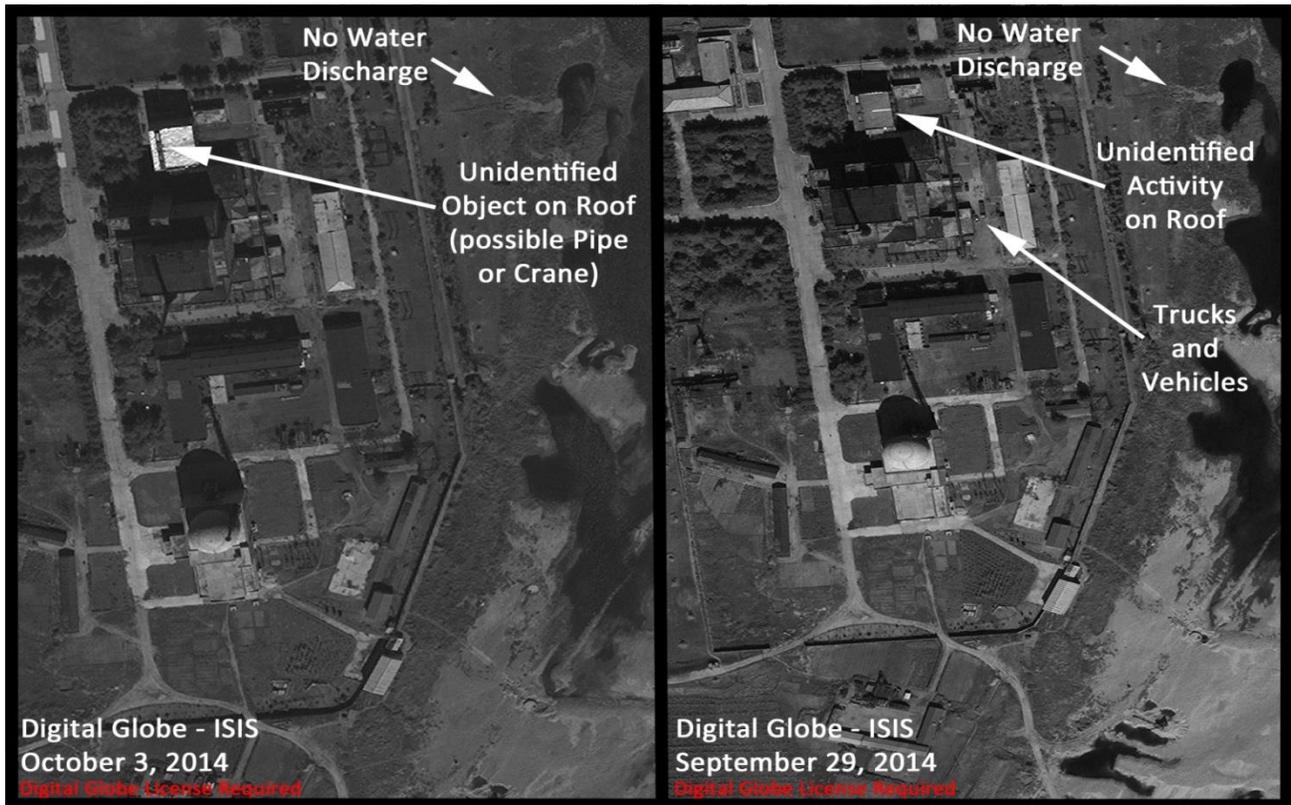
Figure 1. Digital Globe imagery showing North Korea’s Yongbyon 5 megawatt-electric (MWe) and experimental light water reactors on September 29 and October 3, 2014.

On October 3, 2014, ISIS published an [Imagery Brief](#) on the status of North Korea's Yongbyon 5MWe reactor, concluding that the reactor appeared shut down for maintenance or partial refueling. Analysis of a new October 3, 2014 Digital Globe image is consistent with that finding (see figure 1).

However, in imagery dated August 27, September 29, and most recently October 3, 2014 both these signatures are missing (see figures 1 and 2; figure 3 shows the water being discharged). There is no steam venting from the turbine building and no water is being discharged from the secondary cooling system’s discharge pipeline. ISIS also found no evidence indicating that the discharge pipeline for the 5 MWe reactor’s secondary cooling system has been relocated. If North Korea had made the decision to relocate the discharge piping, evidence such as a new discharge location or excavation related to the laydown of new piping should have been visible. Although ISIS has not identified any such activity, we will continue to monitor for this possibility.

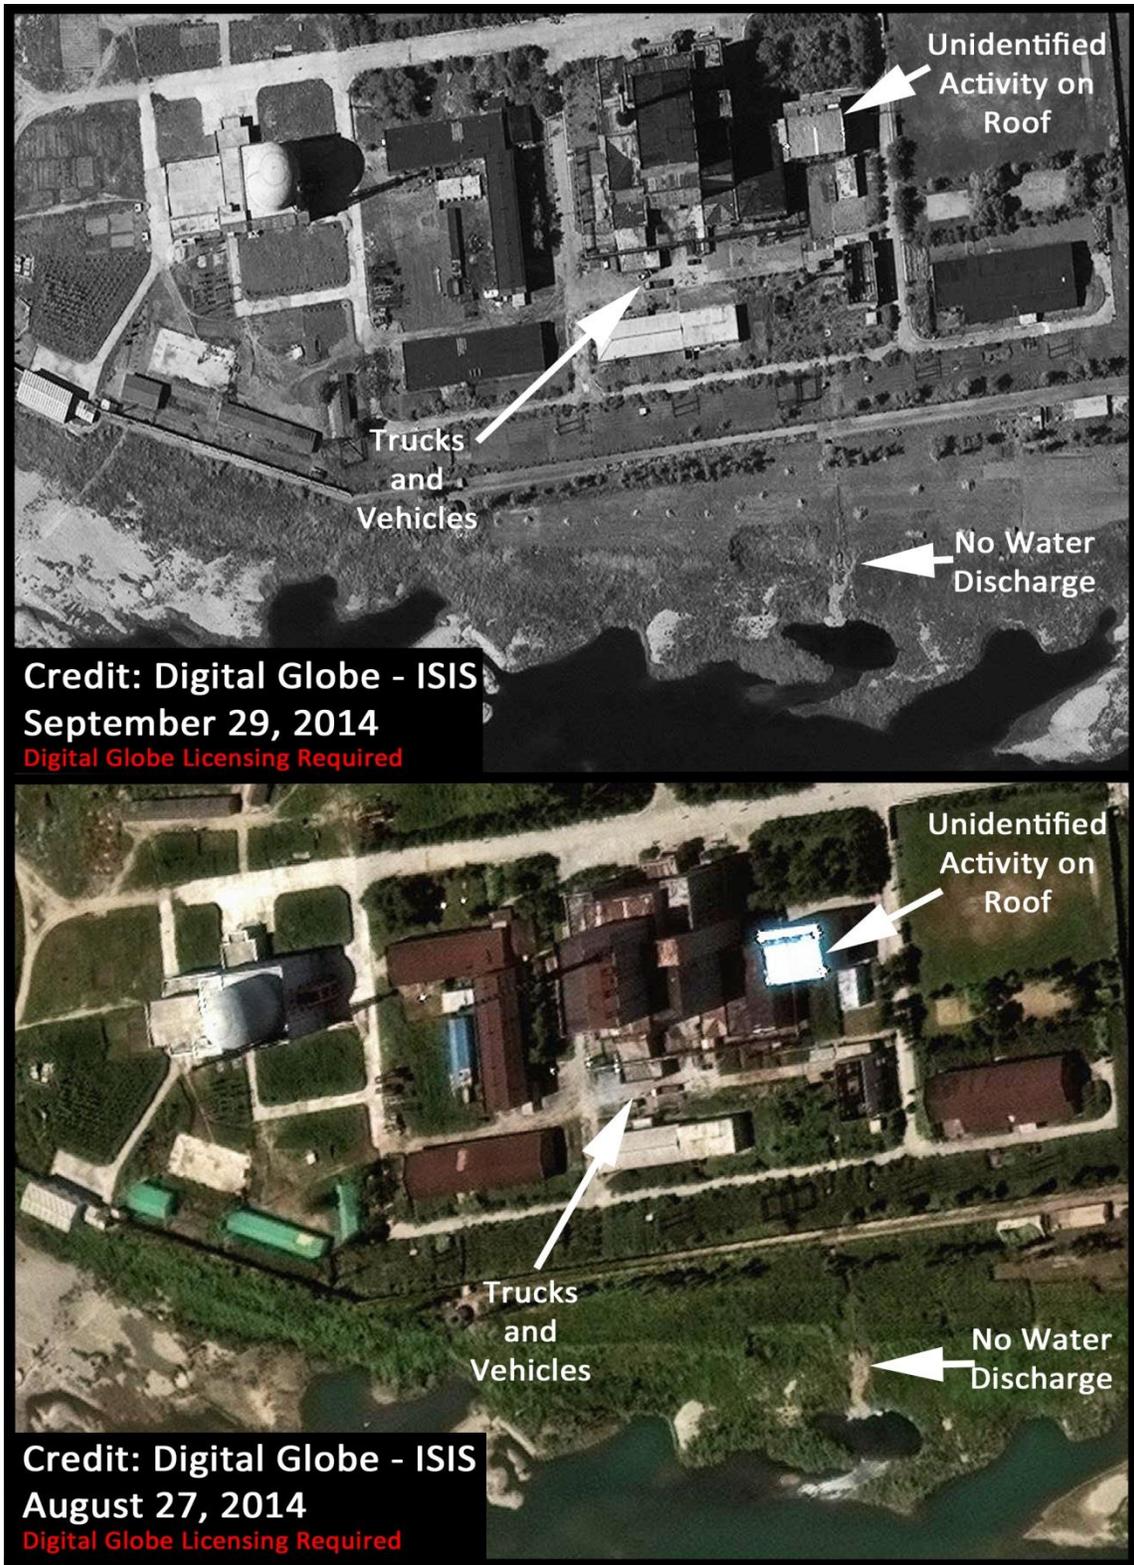
Figure 2. Digital Globe imagery showing North Korea's Yongbyon 5 megawatt-electric (MWe) and experimental light water reactors on August 27 and September 29, 2014.

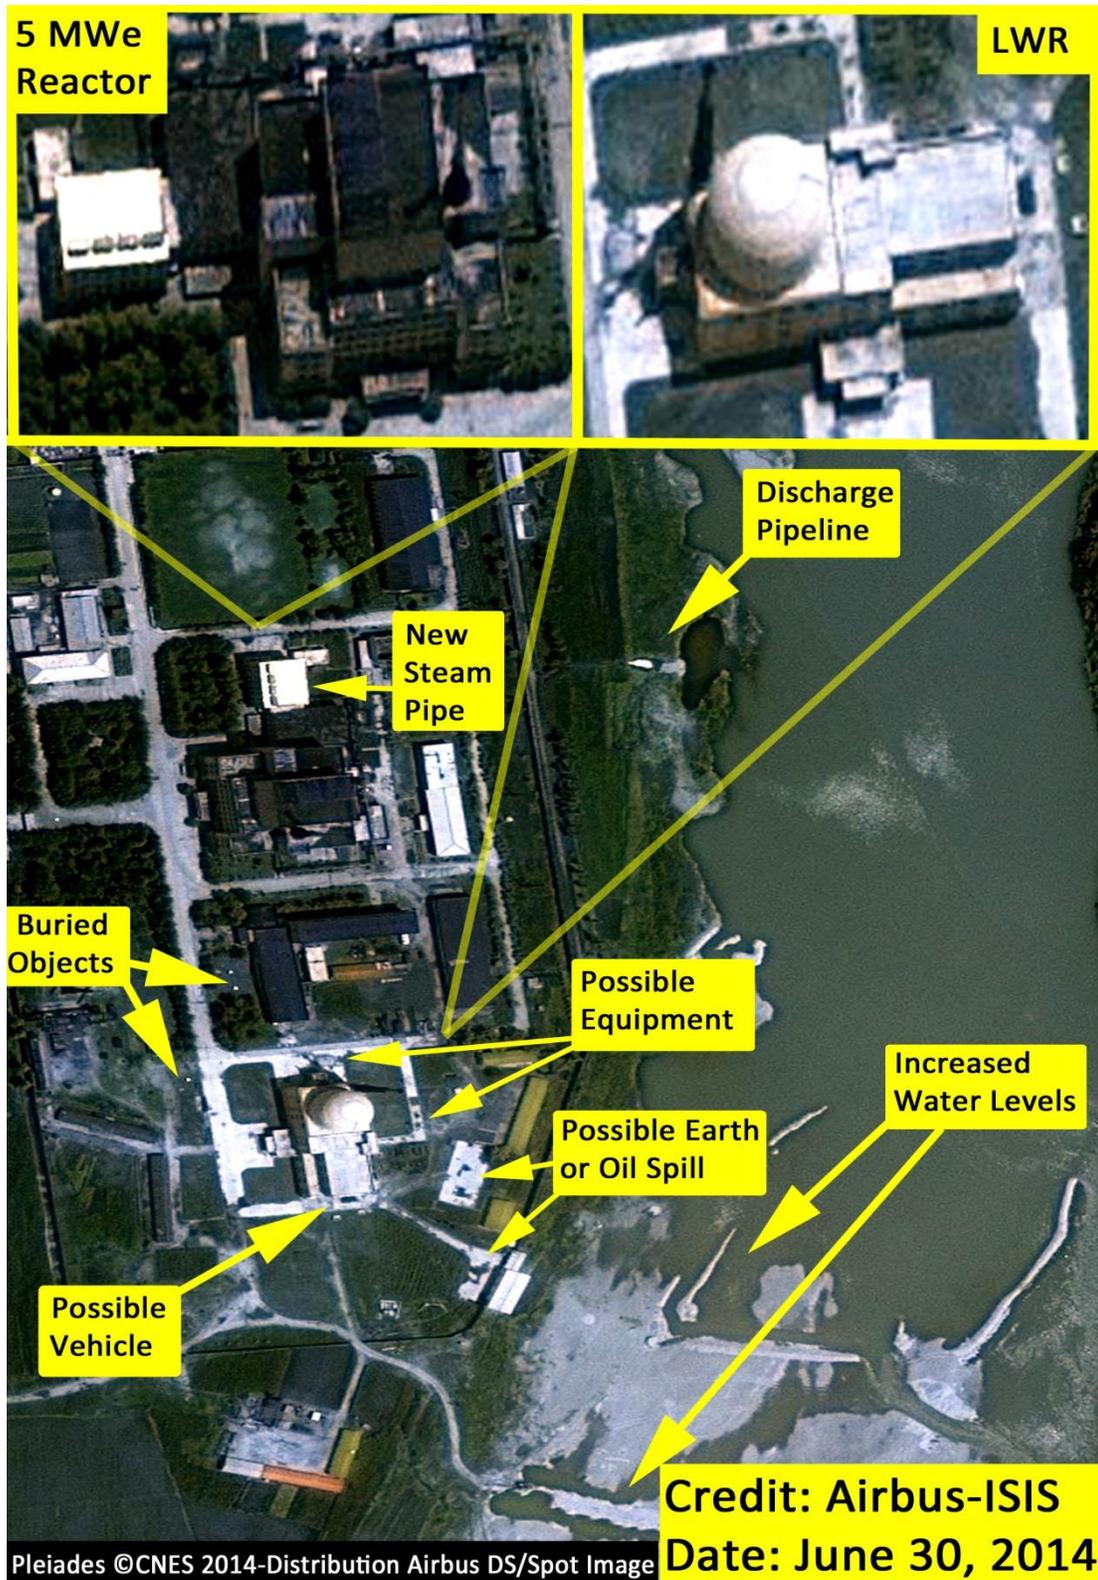
Figure 3. Airbus imagery showing North Korea's Yongbyon 5 megawatt-electric (MWe) and experimental light water reactors on June 30, 2014.
