## Mysterious Fire and Explosion in the New Natanz Advanced Centrifuge Assembly Facility

By David Albright, Sarah Burkhard, and Frank Pabian

July 3, 2020

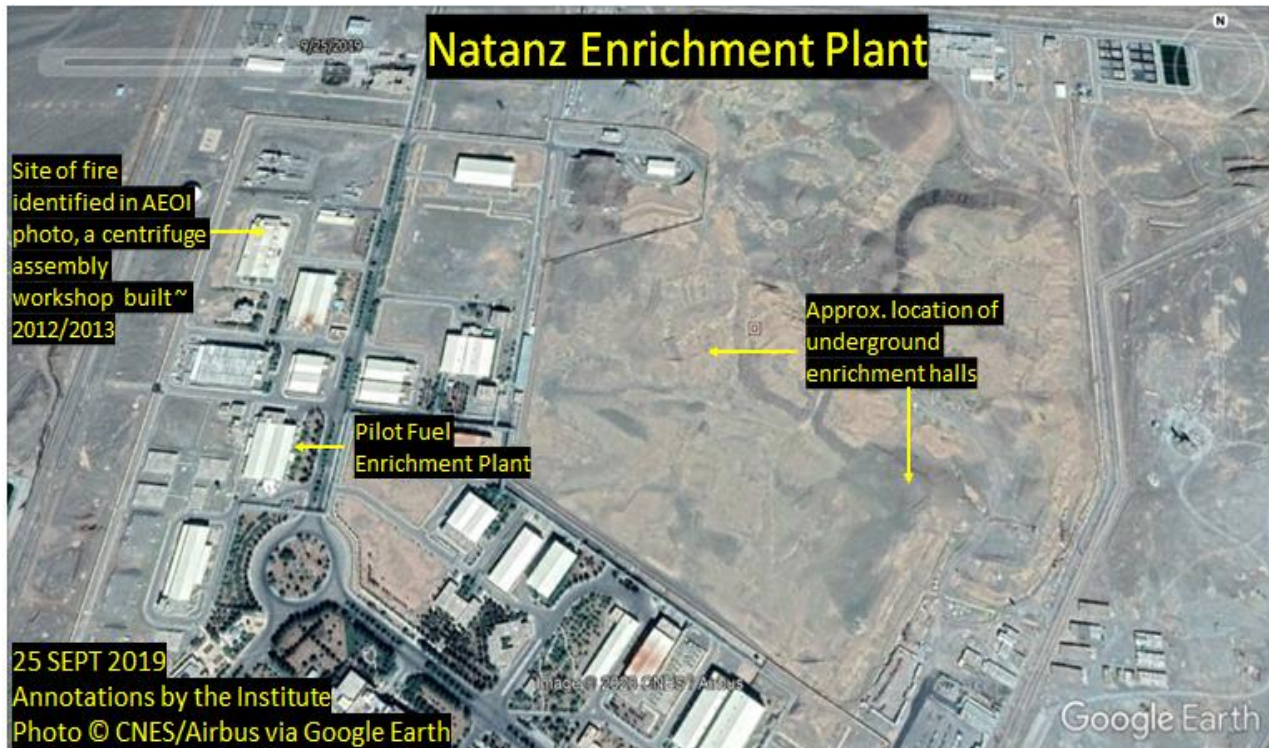
**Figure 1.** The site of the fire was identified by the Institute as the new advanced centrifuge assembly workshop, located near the Natanz Pilot Fuel Enrichment Plant. Both are important features of the Natanz enrichment plant, with the assembly workshop being a critical part of Iran’s plan to deploy thousands of advanced centrifuges.

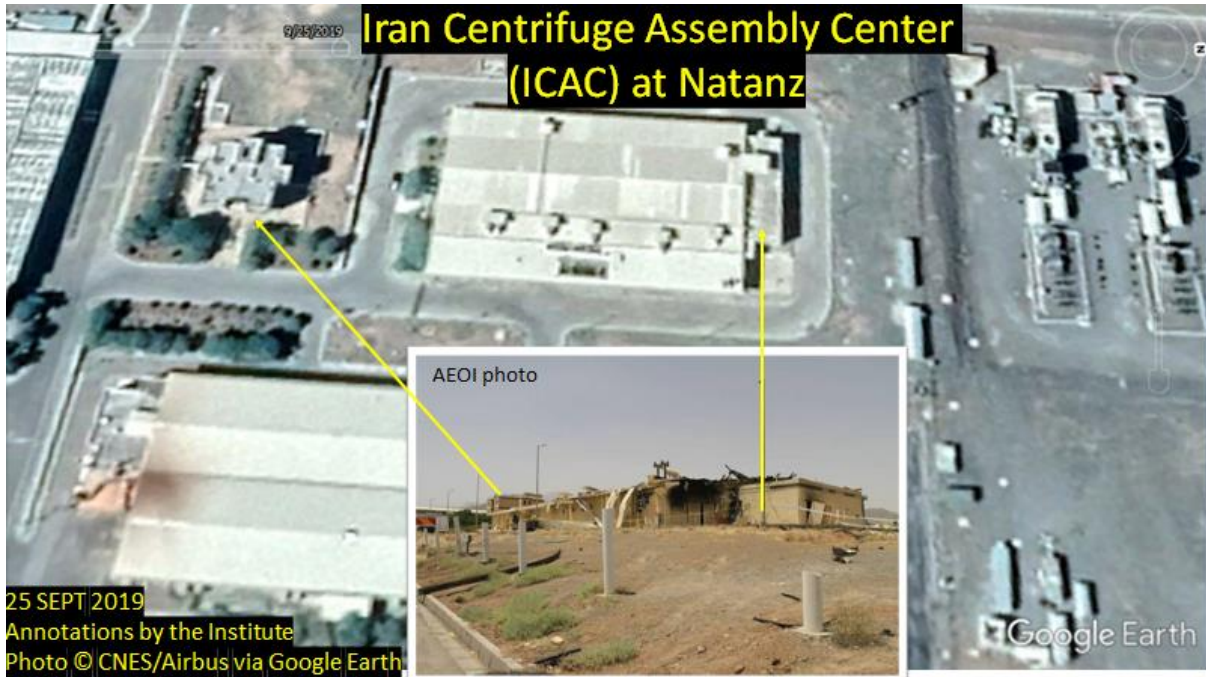
Based on the post-fire and explosion photo published by the AEOI, the incident appears to have caused significant structural damage to the building, visible as cracks in the walls, and doors unhinged, along with destroyed roof panels. A freeze frame from another video shows the eastern wall damage in more detail with the area cordoned off with yellow tape (see Figures 3 and 4). The area of the most severe damage is visible in the northeast corner of the building where there are twin vent stacks on the roof, suggesting that the section under the stacks was the center of the fire and explosion (see Figures 5 and 6). Our assessment is that the area likely contained twin auxiliary diesel generators for electric back-up power and some onsite fuel storage. While that section might be described as a "shed," it was clearly not the only part that suffered damage, and it was an integral part of the ICAC building.

**Figure 2.** Geolocating the building in satellite imagery, using the ground photo published by the Atomic Energy Organization of Iran.
