REPORT

## Satellite Imagery Update on Alabuga Shahed-136 Drone Factory

By David Albright, Sarah Burkhard, and Victoria Cheng<sup>1</sup>

**December 20, 2023**

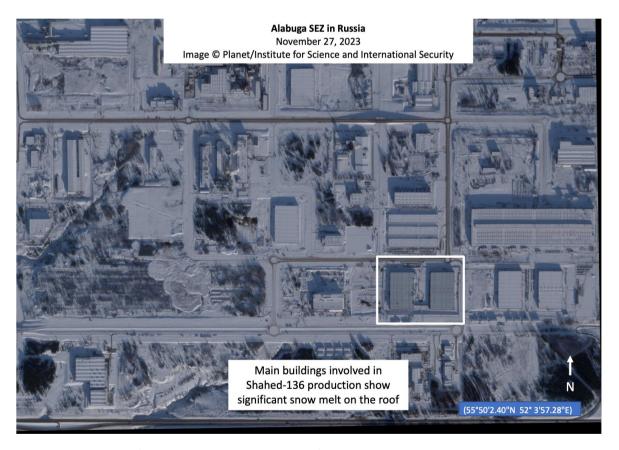
Alabuga numbered the buildings in order of construction, 8.1 and 8.2, where 8.1 is east of 8.2. According to building layouts in internal Alabuga documents, building 8.2 is fully dedicated to Shahed-136 production, and building 8.1 is partially dedicated to Shahed-136 production. As can be seen in Figure 1, all of the visible buildings at the SEZ are notably covered in snow, except buildings 8.1 and 8.2, which only show a thin layer of snow on their roofs. The lack of substantial snow cover suggests the roofs were manually cleaned, not likely for such large buildings, or heat melted the snow on the roofs.

**Figure 1.** Location of the two main buildings used for Shahed-136 production inside the Alabuga SEZ. All other buildings in the vicinity have significantly more snow cover on their roofs.

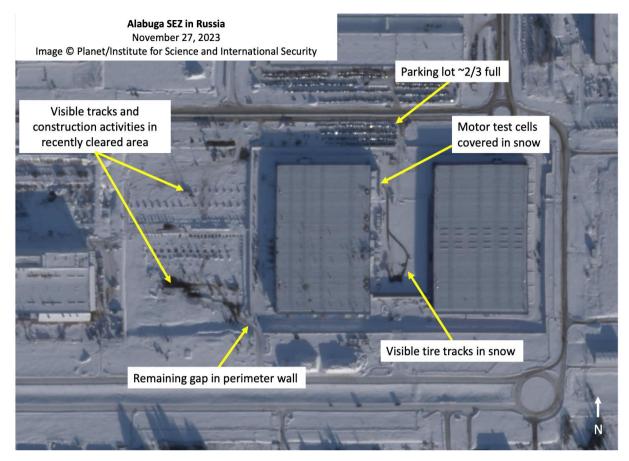
Figure 2, a close-up of the two buildings, shows tire tracks on the snow-covered ground inside the security perimeter between the two buildings, further indicating recent activity. The parking lot outside of the security perimeter is about two-thirds full, indicating staff presence. The roof of a series of motor test cells identified in the building 8.2 layout in internal Alabuga documents do appear to be covered in snow, indicating that the test cells may not have been operating at that time. The security perimeter wall that was visibly

under construction in mid-September<sup>2</sup> appears near completion; a gap remains in the southwest corner.

**Figure 2.** A close-up of building 8.1 (right) and 8.2 (left) shows recent changes and observations around and in the vicinity of the two buildings where Shahed-136 production is taking place.

Further, construction activities are visible in the open field west of the security perimeter wall enclosing buildings 8.1 and 8.2. This area was leveled in 2021 when buildings 8.1 and 8.2 were constructed, but used as a construction dump site until at least May 2022. Sometime between May 2022 and July 2023 the site was cleared, and as of July 2023 the wet areas were being filled with dirt. As of late November, tire tracks and dirt mounds visible in the snow indicate ongoing construction in this area. Multiple parallel rows of pillars are visible, likely for one or two buildings with a combined floor space similar to building 8.2. The immediate adjacency of this construction to the drone production site, no apparent shortage of usable plot at the Alabuga SEZ, and the relatively large remaining gap in the security wall on the southwest corner raise the question whether the new construction is related to the drone production buildings, such as having a supportive function (providing additional utilities, parts/materials warehousing, etc.)
