Presence of Undeclared Natural Uranium at the Turquz-Abad Nuclear Weaponization Storage Location

By David Albright, Sarah Burkhard, Olli Heinonen¹, and Frank Pabian²

November 19, 2019

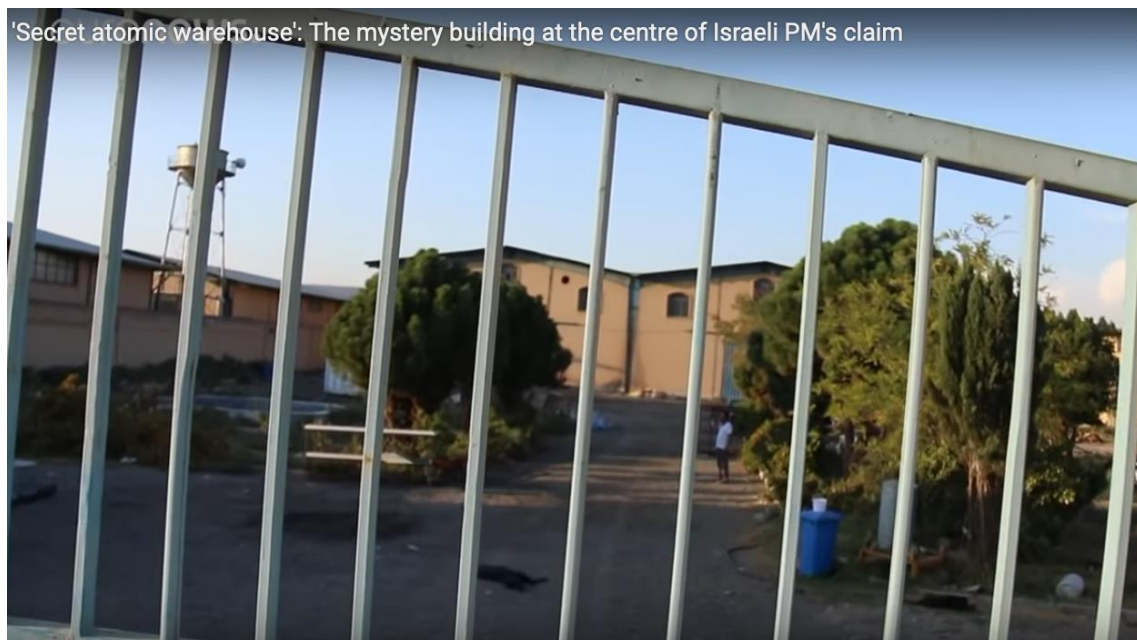
Figure 2. A ground photo of the Turqz Abad site, taken from outside of the gated entrance. Dated September 30, 2018, following Israeli Prime Minister Netanyahu's description of the site at the United Nations on September 27, 2018, and consistent with comparison of overhead imagery from that time. Credit: Euronews, <https://www.youtube.com/watch?v=fszsjHyGSUJ>.

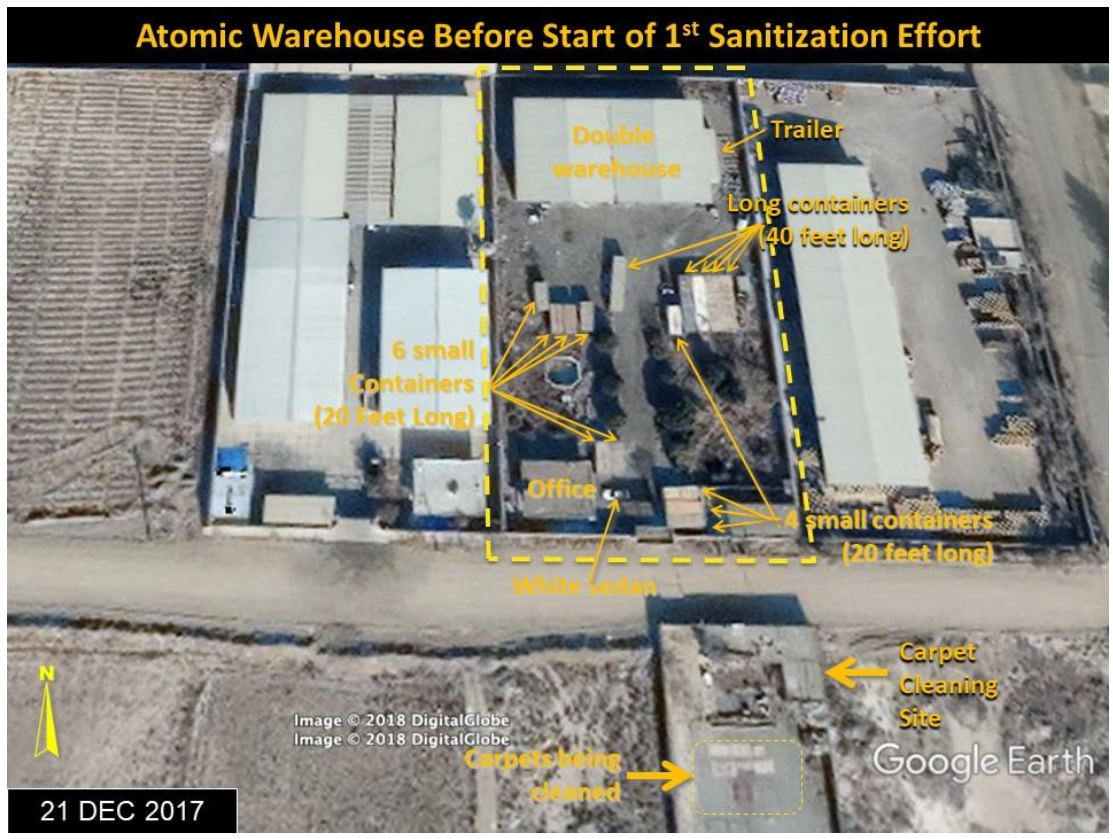
Figure 3. The Atomic Warehouse before first sanitization that started in mid-2018.

Figures 3 to 5 show the Turqz-Abad site in 2017 and 2018 before, during, and after what can be called the first sanitization effort, summarizing the comprehensive imagery timeline published in the earlier Institute study. By the time Netanyahu announced the existence of the site in September 2018, the latter imagery shows the removal of the shipping containers and other equipment from the site.

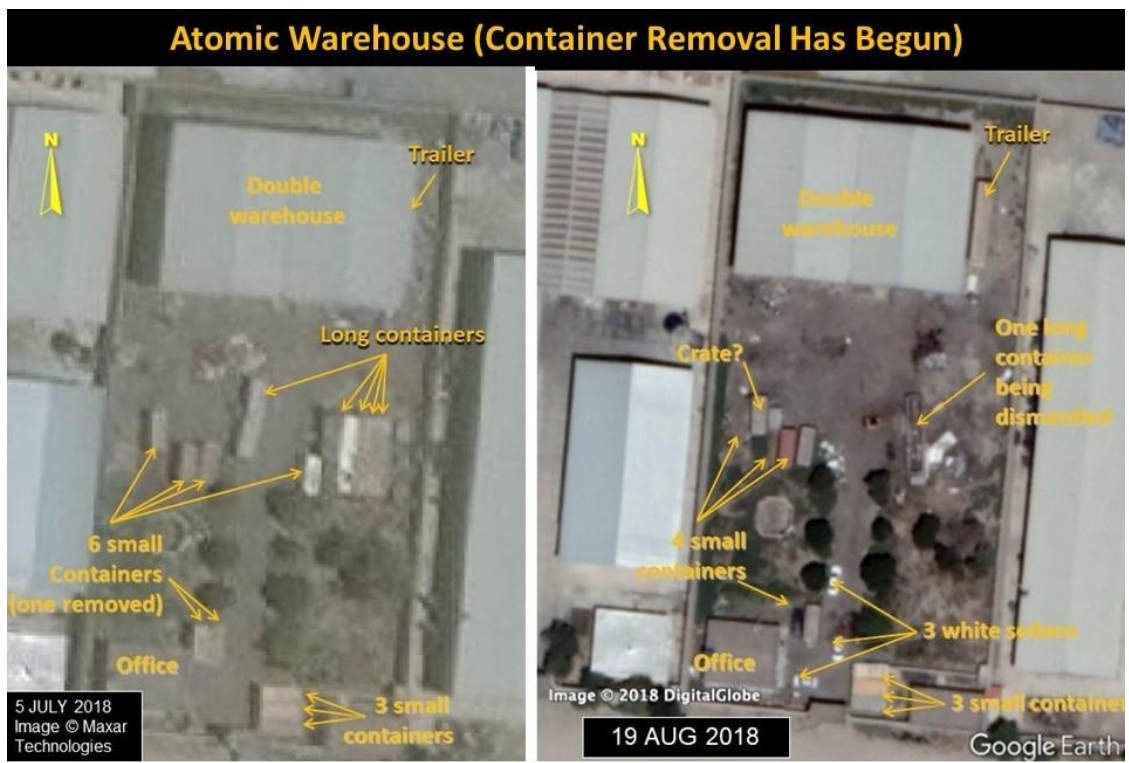
Figure 4. Shipping containers were removed during the summer of 2018.

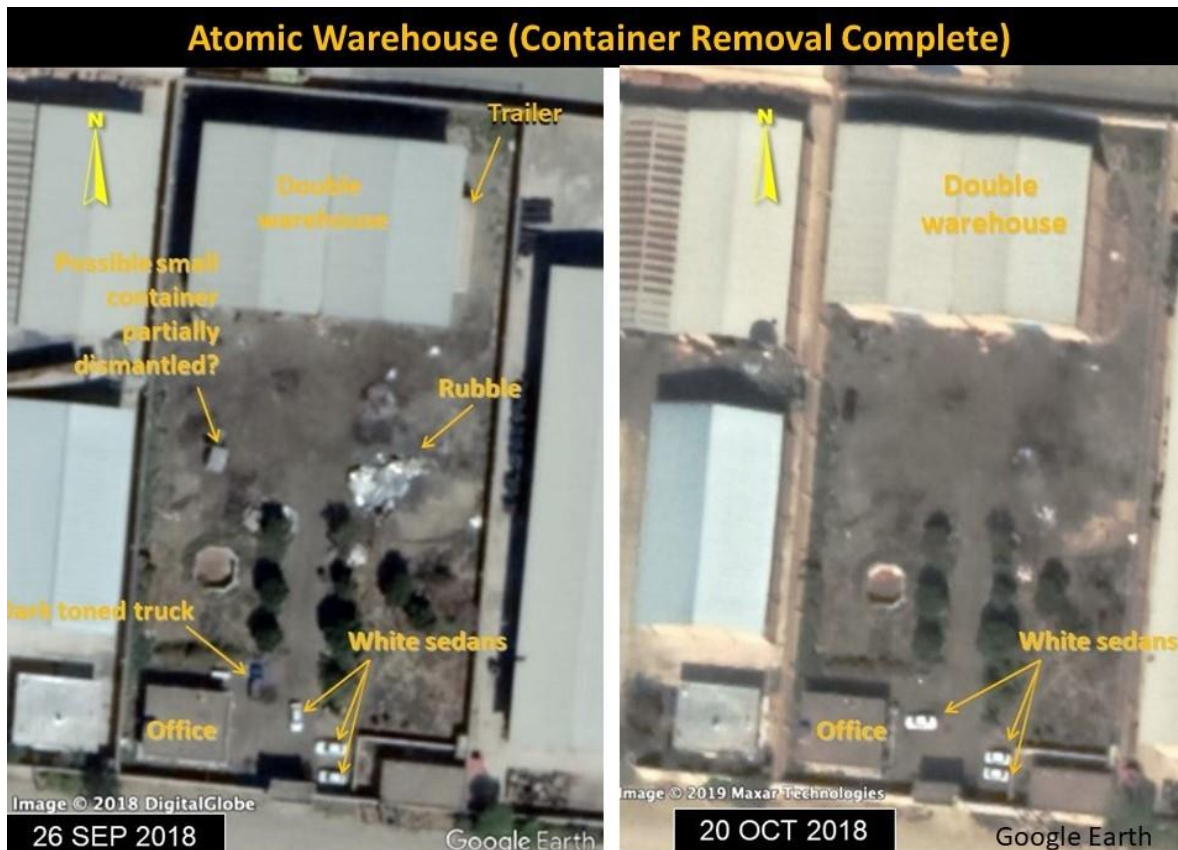
Figure 5. By September 20, 2018, almost all containers had been removed. By October 20, 2018, the site was almost empty.

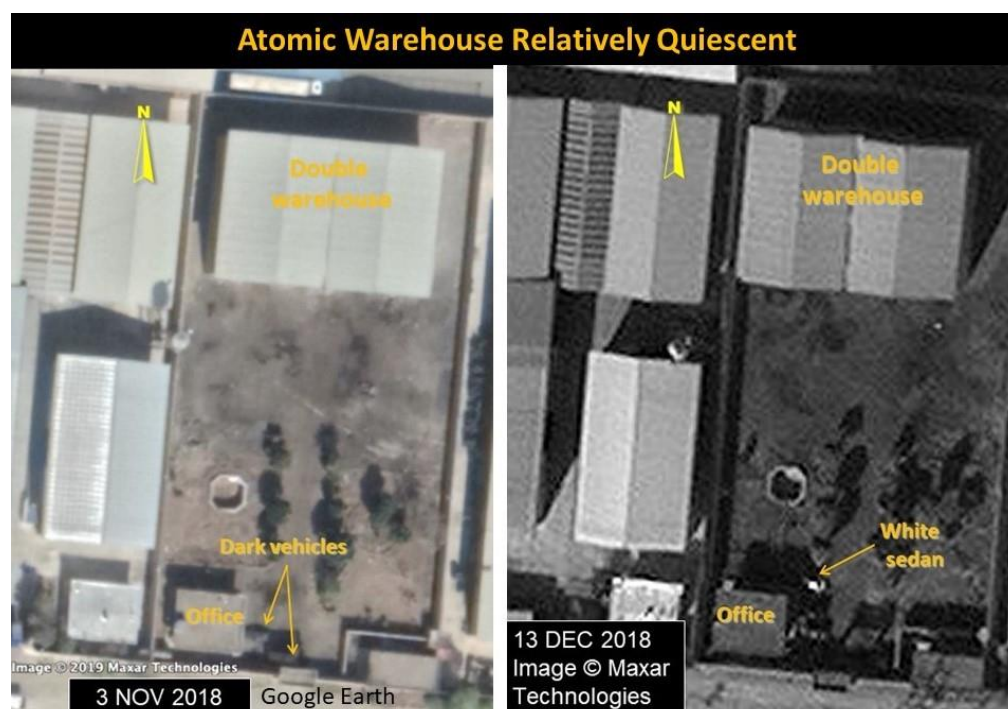
Figure 6. The site remains relatively quiescent during November and early December 2018.

Figures 6 to 9 show the site from November 2018 until late February 2019, a period during which the site first looked relatively clear, and then underwent an apparent intensified second round of sanitization activities.

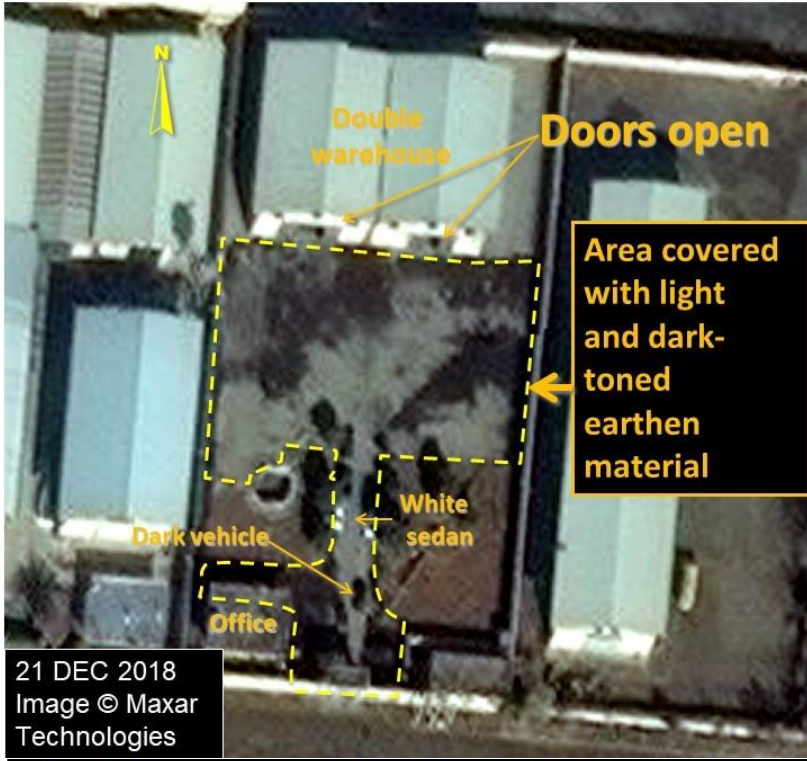
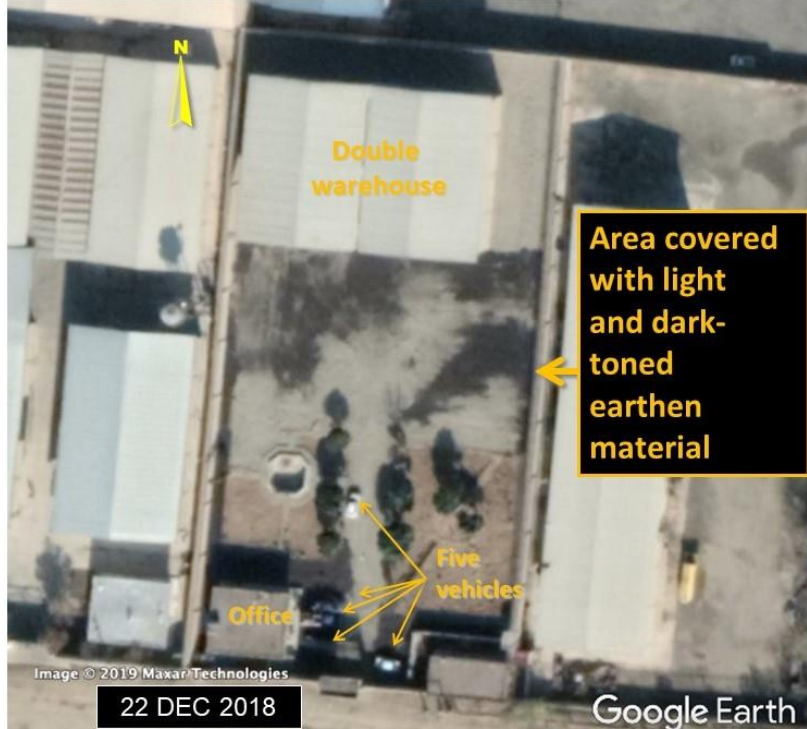
Atomic Warehouse: Probable 2nd Sanitization Effort Underway

Starting after mid-December 2018, a light tan-colored earthen material, possibly soil or crushed rock/gravel,¹³ appears to have been spread across the site. Mixed with a darker material,

possibly darker soil or asphalt, this material was placed by December 21, 2018. The material does not appear to be a spill but deliberately and carefully placed. Notably, it appears where some of the previously removed containers had been located, and also where apparent burn sites used in May and June 2018 were located.

Figure 7. After mid-December 2018, light and dark earthen material was spread across the site.

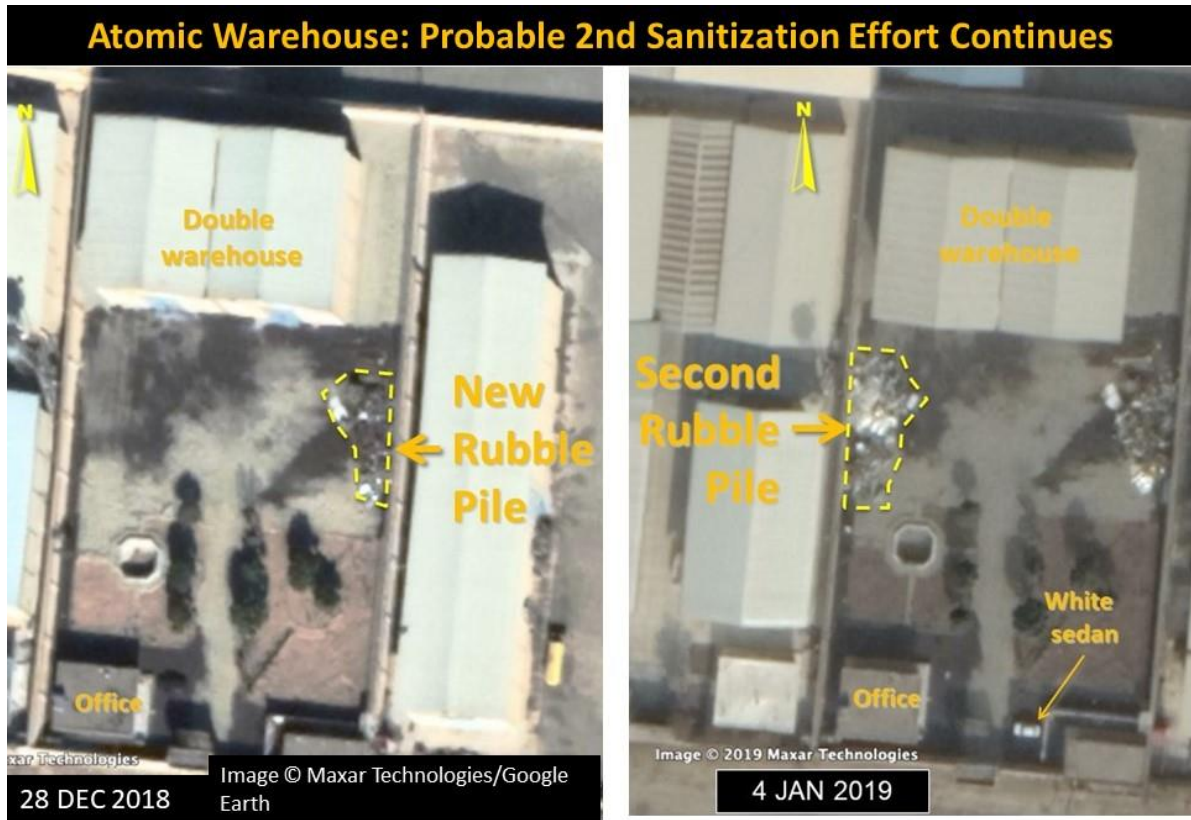
Starting around December 26, rubble was eventually placed on nearly all of the areas where the earthen material had been spread. The rubble pile distribution reached its peak volume by February 19, 2019, just three days before the IAEA visit.

Figure 8. Rubble was placed in late December 2018, and the pile grew in January.

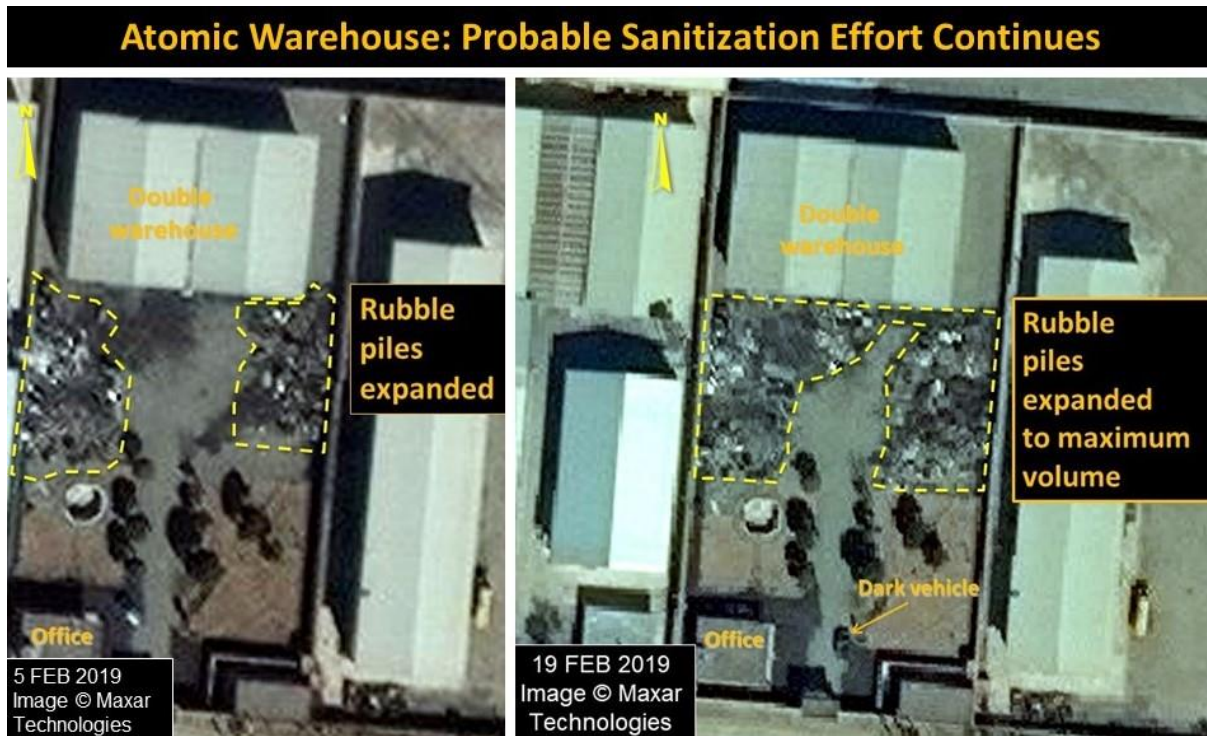
Figure 9. By February 19, 2019, three days before the IAEA visit, the rubble pile grew to cover almost the entire area in front of the double warehouse.

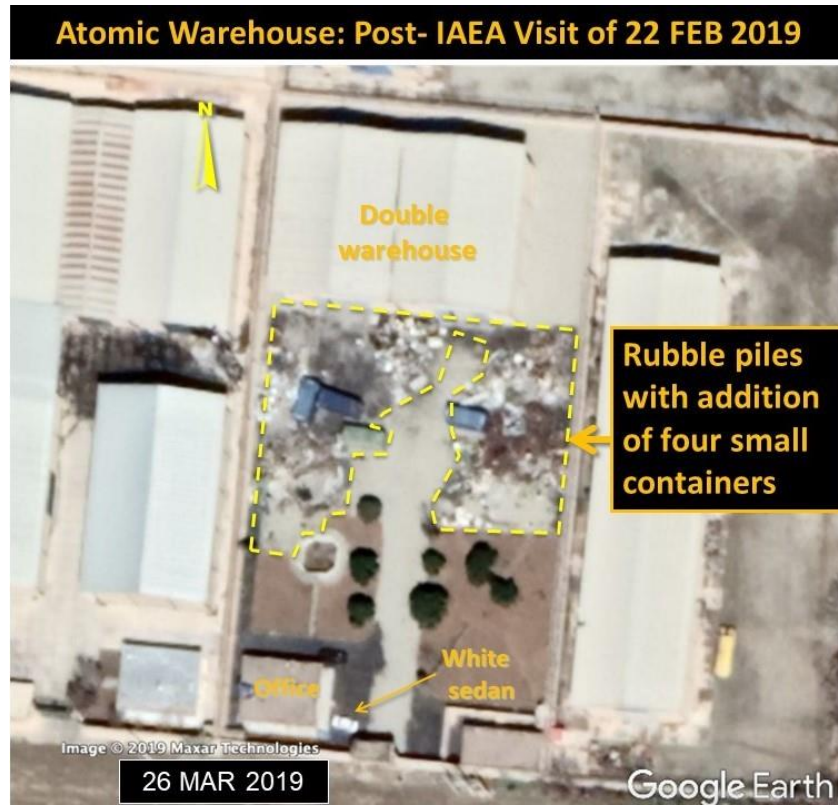
Figure 10 shows the appearance of the site soon after the IAEA visit, with the addition of small containers. Figure 11 is an image of the site on October 14, 2019, and most notably, all the rubble piles have been completely removed, but the darker underlying material patterns appear similar to what was observed before the rubble piles were emplaced.

Figure 10. By the end of March 2019, four small containers appeared among the rubble piles.

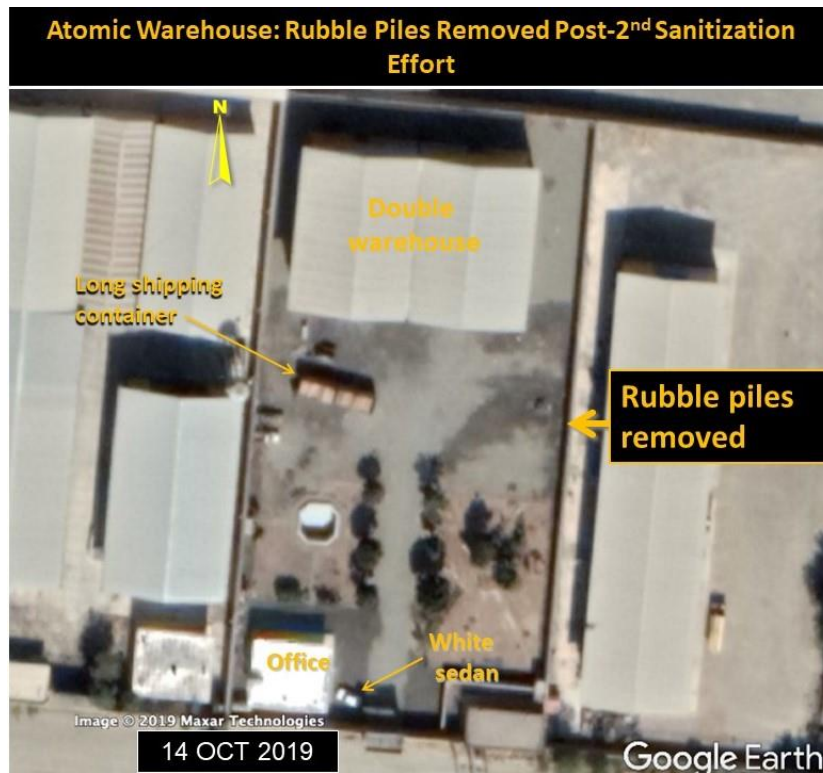
Figure 11. The site is cleared again after the IAEA visit, and by October 14, 2019, all the rubble had been removed.

As we have recommended previously, it is urgent that Iran be pressed to produce all the nuclear-related equipment and material, and any associated documentation, previously stored at the Turqz-Abad site. There is no evidence that Iran systematically destroyed these items, which in any case should occur under IAEA monitoring
