Post Script: Looking at the new construction activity near Natanz from a new perspective

November 5, 2020

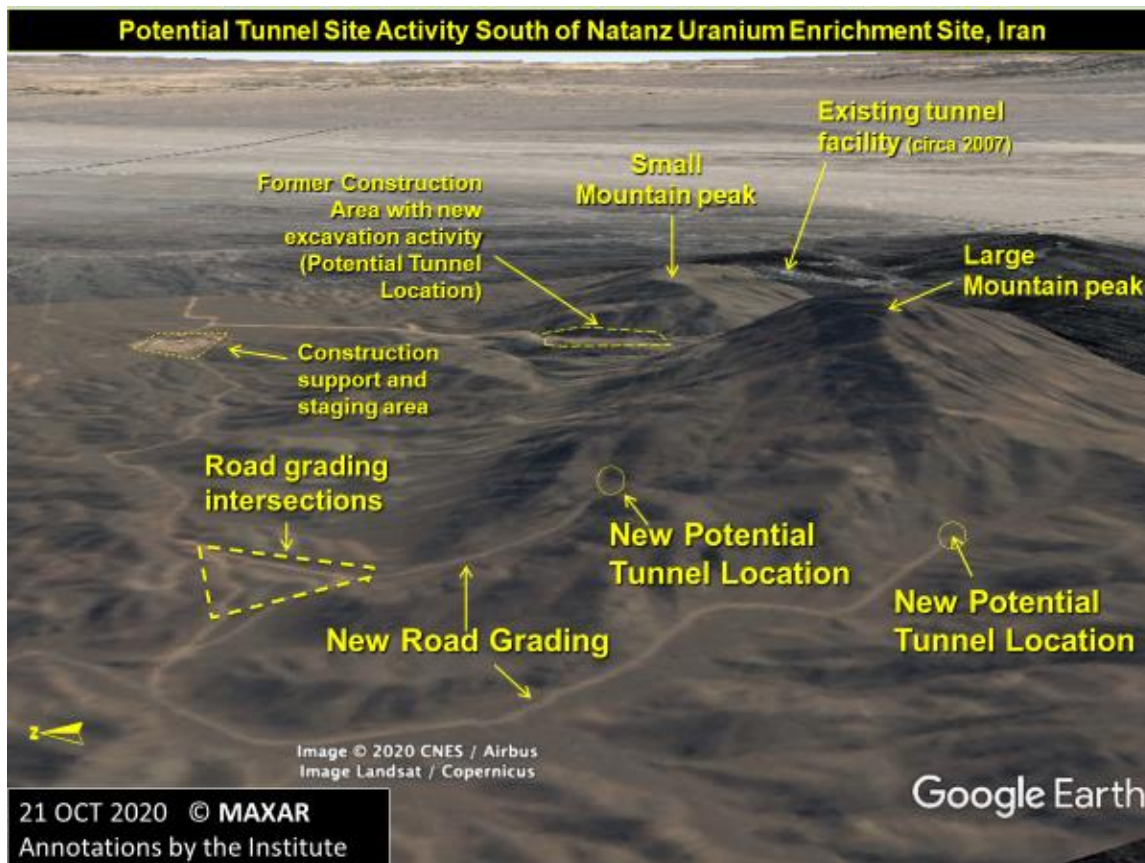
Figure. An overlay of the October 21, 2020, satellite image on a Google Earth perspective view reveals two new potential tunnel locations.

On October 30, 2020, the Institute released a [report](#), “Update on New Construction Activity at Natanz,” which briefly discussed new road grading activity to the west of the staging area for the new centrifuge assembly facility. The new road grading activity appears to be road intersections between two graded roads leading to the base of a large mountain. This was determined by overlaying the latest MAXAR image dated October 21, 2020, onto Google Earth. Rotating the overlay to see the terrain view (looking east) from a new perspective, shows clearly that the two graded roads from that intersection eventually dead end at the base of the larger of the two mountain peaks (See Figure below). This at least suggests that these should now be labeled as two new potential tunnel entrance locations.
