## Basic Attack Strategy of Stuxnet 0.5 rev. 1

By the Institute for Science and International Security (ISIS)

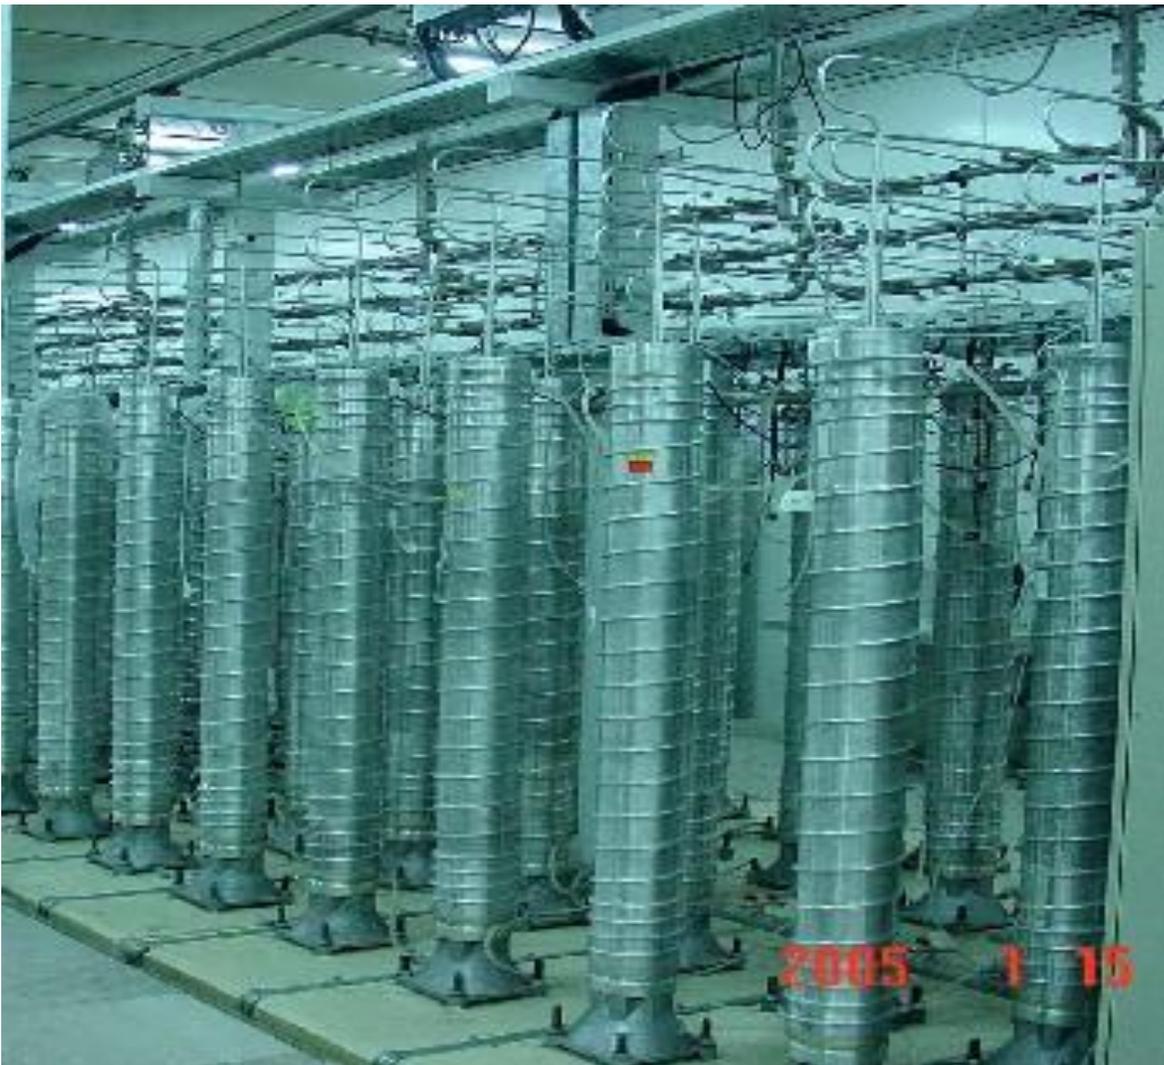
Figure 2, IR-1 cascade in the Natanz Pilot Fuel Plant, showing the pipework above the centrifuge.

Based on an analysis of the code and the Natanz cascade, the most likely valves closed are the three fast acting valves on the three thin pipes for feed, product, and waste (or tails) that pass through the top cap of an IR-1 centrifuge (see figure 2). The three fast-acting electronically-controlled valves are part of an emergency response system of the cascade aimed at protecting the remaining centrifuges in the cascade from the effects of a crashing centrifuge. If a centrifuge crashes, or there is an imminent risk of one crashing, the computer monitoring system closes the valves of the affected centrifuge rapidly, effectively isolating it. The kinetic energy of a rotating centrifuge is huge. Because this energy is converted mainly into heat, a crashing centrifuge produces a large pulse of hot uranium hexafluoride gas and other gases that must be contained. Otherwise, this pulse travels down the cascade, taking out additional centrifuges in its path. Thus, the emergency system is designed to act within milliseconds in the event of an anticipated crash and isolate the centrifuge from the cascade. The Natanz cascade emergency response system appears to rely principally on a vibration sensor, an accelerometer, on each centrifuge. Many pressure transducers are also in each cascade to measure pressure, but the most important sensor to detect crashing appears to be the accelerometer. This sensor sends a shut-off signal to the computer monitoring system if the vibration level exceeds a certain, dangerous value.
